The Newsletter of the Colorado Riparian Association

Volume 17, Number 4, Winter 2006

Riparian Willow Restoration at Arapaho National Wildlife Refuge

by Gregor T. Auble and James E. Roelle, U.S. Geological Survey, Fort Collins Science Center, and Ann Timberman, U.S. Fish and Wildlife Service, Arapaho National Wildlife Refuge

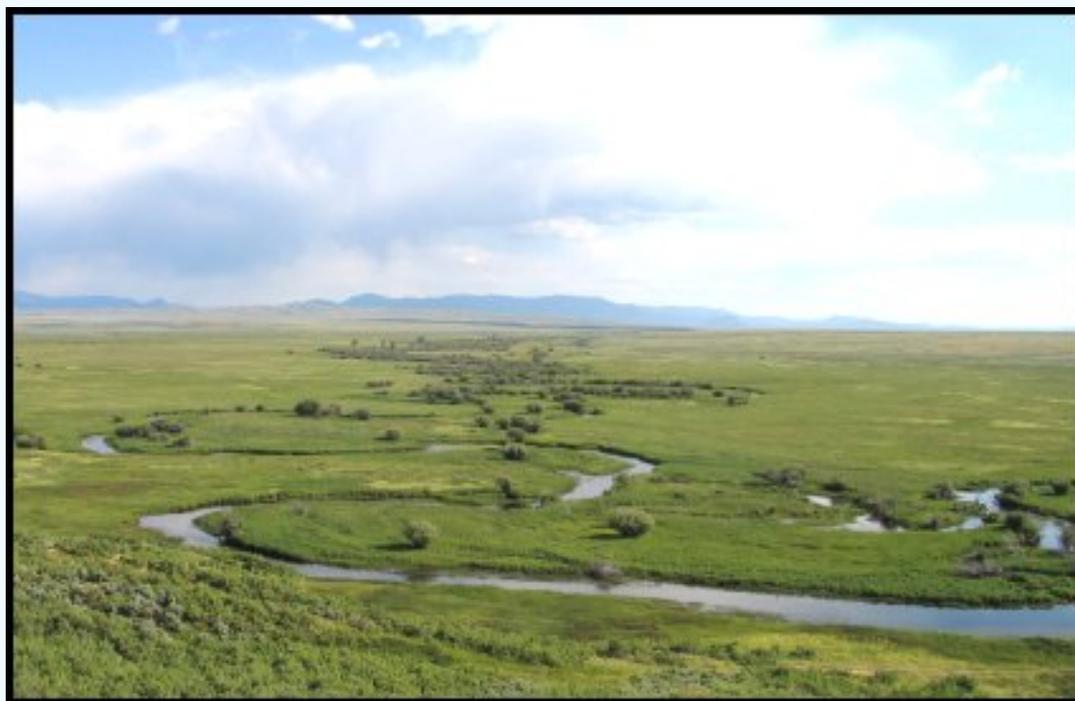
Photo 1. Sparse willow along portions of the Illinois River. View is looking upstream (south) from the Arapaho National Wildlife Refuge overlook off Highway 14 near Walden, Colorado.

habitat for a number of wildlife species, including neotropical migratory birds. Existing stands in the northern (downstream) portion of the refuge are sparse and discontinuous (Photo 1) compared to upstream portions of the Illinois River and the parallel Michigan River.

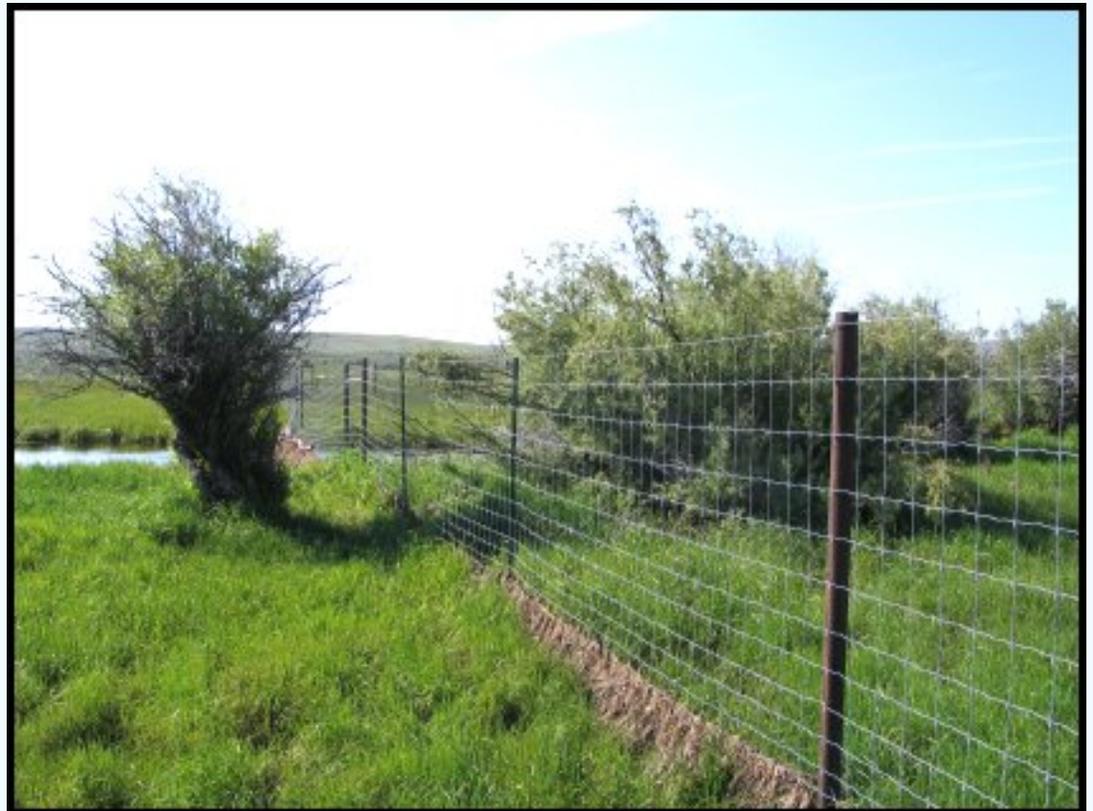
Photo 2. Fence-line contrast at one of the permanent exclosures shortly after overbank flow in 2005. The exclosure was constructed in 2003. Note the notched, browsed growth form of willow on the left (outside the exclosure) and fencing maintenance problems at the river crossing.

We have been testing two types of management actions: (1) exclosures to minimize or eliminate ungulate herbivory on willow and (2) planting to bypass the apparent bottleneck of natural seed regeneration. Tall, welded-wire exclosures with paired control plots and groundwater-monitoring wells were constructed at five locations in 2003, with the assistance of the Colorado Division of Wildlife, to support a long-term experiment, with the first re-sampling scheduled for 2007. Incidental observations of individual plants suggest that the exclosures are beginning to produce greater overall shoot growth of willow, especially height growth of suppressed individuals initially less than 1.5 m tall. This type of fencing is expensive to construct and maintain, especially at bank or channel crossings. Thus, we have also begun to experiment with small fenced patches in off-channel depressions associated with relict channel locations. In these sites, existing small willow and planted material might be partially protected from ungulate herbivory by traditional barbed-wire fencing installed by volunteers.

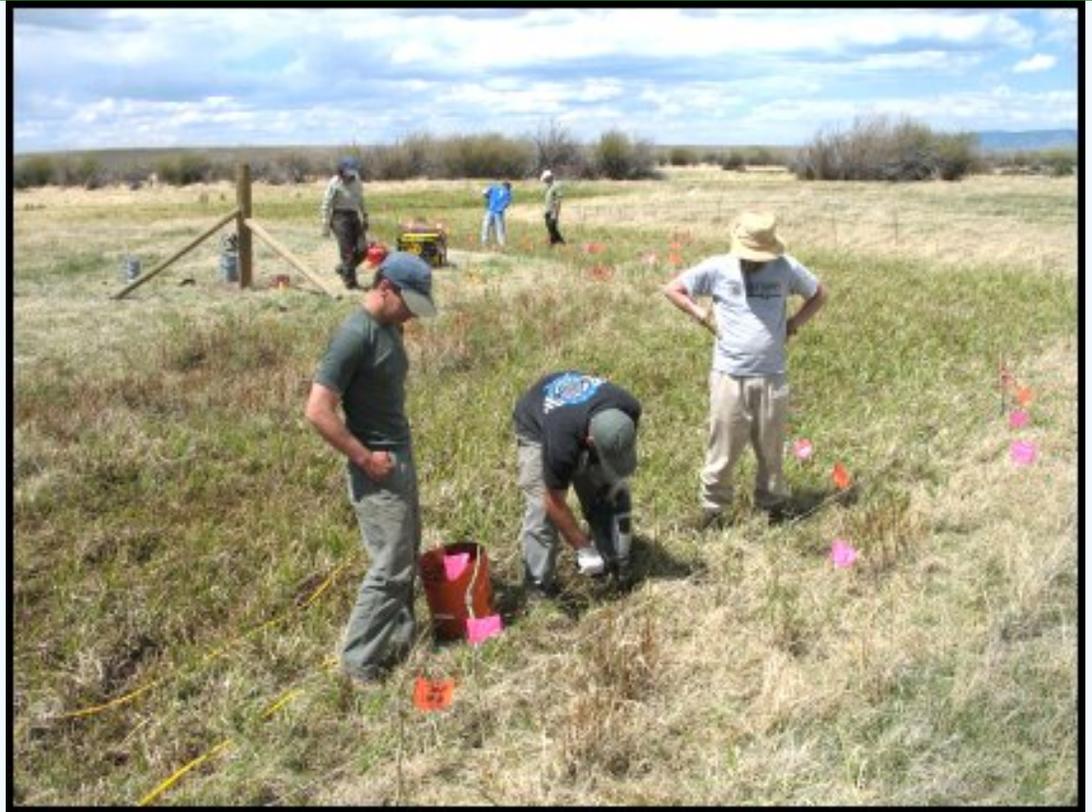
Photo 3. Wildlands Restoration Volunteers constructing temporary fencing and using a generator-powered hammer drill to plant willow (*Salix monticola*) poles in a relict channel location, May 2006. Some herbivory-suppressed, short *Salix geyeriana* are visible in the foreground.

Initially, planting actions have focused on pole planting in 1 meter holes near the time of spring bud-break using recently harvested, local plant material. Design considerations included (1) planting deep enough to maintain contact with groundwater even in late summer, (2) using local material, (3) affordably establishing large numbers of plants, and (4) effectively using a "pulsed" work force of volunteers. In the first three years, we have tried a combination of species (*Salix lasiandra*, *S. geyeriana*, *S. exigua*, and *S. monticola*) and hole-digging equipment (auger on tracked skidsteer, gasoline-powered hand auger, pump-powered water jet, generator-powered hammer drill with long bit (Photo 3), and hand-inserted metal spikes). Choices about equipment are complicated by the fact that the best time to plant ecologically, i.e. spring, is also the time when access is most difficult and unpredictable for vehicles and for hand-carrying heavy, unwieldy equipment.
