# Beaver dams, hydrological thresholds, and controlled floods as a management tool in a desert riverine ecosystem, Bill Williams River, Arizona

Douglas C. Andersen<sup>1\*</sup> and Patrick B. Shafroth<sup>2</sup>

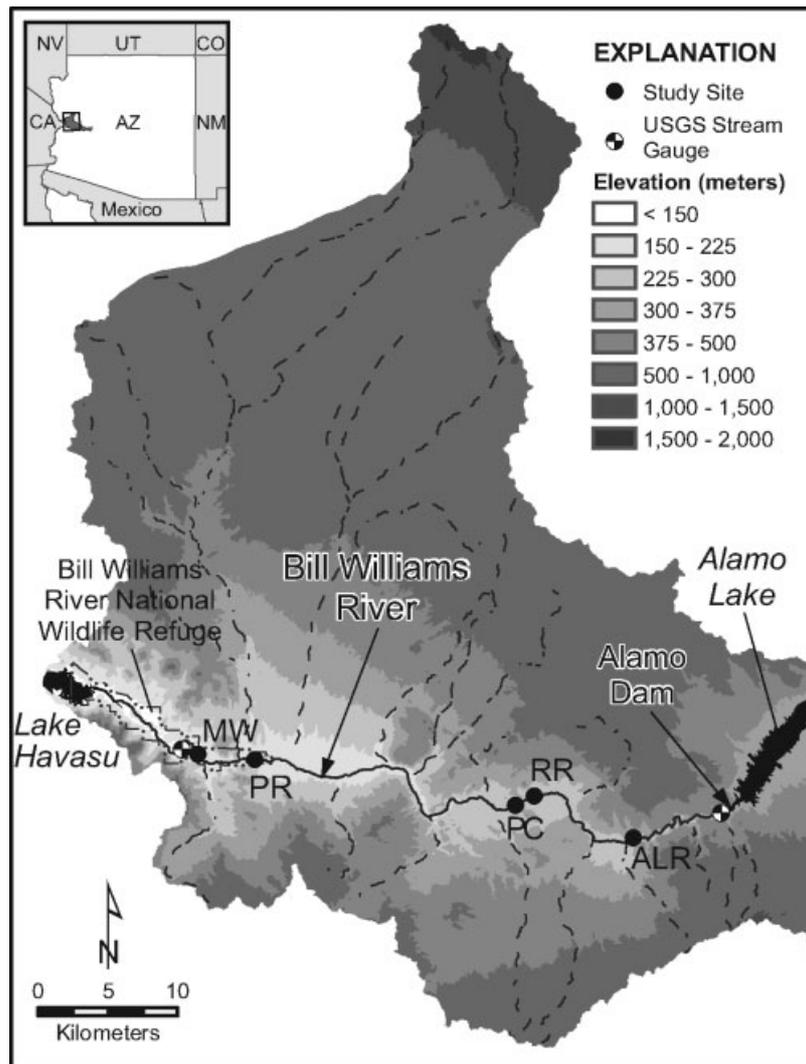
Figure 1. Map of the Bill Williams River (BWR) and its contributing basin below Alamo Dam showing the five reaches where flood effects on beaver dams were monitored from the ground [filled circles: Above Lincoln Ranch (ALR), Rankin Ranch (RR), Pipeline Crossing (PC), Planet Ranch (PR), and Mineral Wash (MW)] and the up- and downstream USGS stream gauges (quartered circles). Tributary wash drainage patterns (dashed lines) have been simplified for clarity. Digital elevation data are from the ASTER GDEM, Courtesy of NASA.

We worked along the ~58-km-long Bill Williams River (BWR) downstream of Alamo Dam in west-central Arizona (Figure 1). The river descends from an elevation of ~300 m above sea level (ASL) at the dam base to ~136 m at its mouth at Lake Havasu, a reservoir on the Colorado River. The BWR passes through a series of five relatively wide alluvial reaches separated by more confined canyon reaches. The longitudinal profile of the BWR is relatively flat, even in canyon reaches. The maximum stream gradient, based on analysis of USGS 7.5-min topographic maps, is about 1%, whereas the mean is about 0.3% (House *et al.*, 2006).

were designated Above Lincoln Ranch (ALR), Rankin Ranch (RR), Pipeline Crossing (PC), Planet Ranch (PR), and Mineral Wash (MW) (Figure 1). All study sites were on public lands.

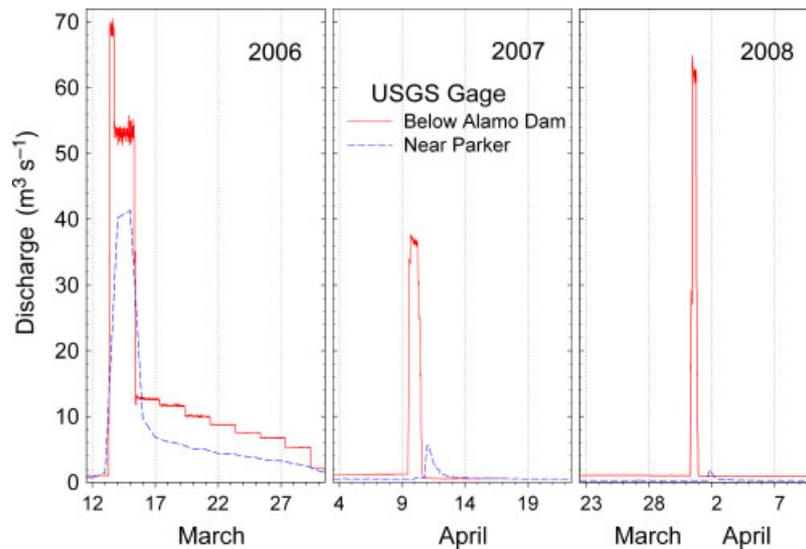
Figure 2. Temporal patterns of the 2006, 2007, and 2008 controlled flood pulses on the Bill Williams River as measured at the upstream (solid line) and downstream (dashed line) gauges, showing the downstream attenuation of the flood peak. With one exception, data are uncorrected real-time instantaneous (15-min interval) measurements at the upstream (Bill Williams River below Alamo Dam) or downstream (near Parker) USGS gauges. The exception is the 2006 data set for the downstream gauge, which consists of mean daily values. Scales are the same in all graphs.

<sup>a</sup> Pulsed release initiated 10 April, 16 h at max = 28.32 m<sup>3</sup> s<sup>-1</sup>, then reduced to 0.57 m<sup>3</sup> s<sup>-1</sup> on 12 April (Figure 2).

Long-duration flood releases again occurred in 2004–2005 (2005  $Q_{\text{MAX}} = 205 \text{ m}^3 \text{ s}^{-1}$ ; Figure 3). Subsequent releases were low ( $\sim 1 \text{ m}^3 \text{ s}^{-1}$  measured at the upstream gauge), with the exception of the experimental spring flood pulses in each of 2006, 2007, and 2008. All three experimental floods rose to peak flow quickly, but duration at  $Q_{\text{MAX}}$  and the subsequent recession rates varied (Figure 2). Peak discharges recorded during the 2004–2005 flood events as well as the first experimental release were similar at the up- and downstream gauges, whereas in 2007 and 2008 the discharge peaks were strongly attenuated by the time the pulse reached the downstream gauge (Figure 2).

We presume the 11-month (minimum) period prior to each experimental flood was sufficient time for beaver to have repaired any weakness in an active dam caused by prior floods. Thus, we consider each flood an independent test of a given dam’s response to a flood. The  $57 \text{ and } 65 \text{ m}^3 \text{ s}^{-1}$  flood pulses each damaged  $\geq 50\%$  of dams. The  $37 \text{ m}^3 \text{ s}^{-1}$  flood also caused at least moderate damage to  $\sim 40\%$  of dams, but that value should be interpreted cautiously because of the small sample size. Perhaps most importantly, we observed significant damage to dams even after  $Q_{\text{MAX}}$  had been attenuated to values approaching  $5 \text{ m}^3 \text{ s}^{-1}$  (Figure 2), and we

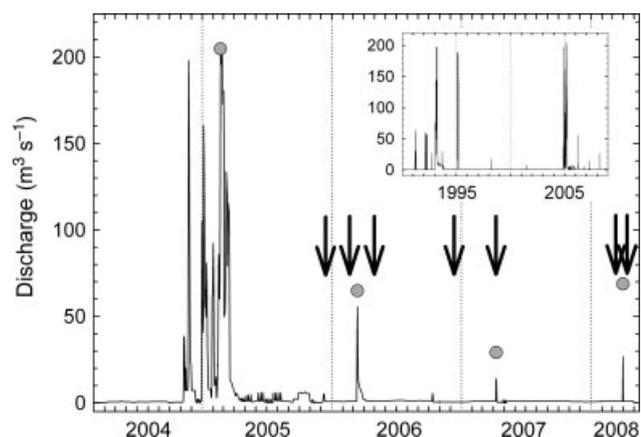
Figure 3. Daily mean discharge in the upper Bill Williams River for the period March 2004 through April 2008, based on data collected at USGS gauge Bill Williams River below Alamo Dam, AZ. The inset shows the same values for 1990–2008. Arrows indicate when site visits and beaver dam examinations took place before and/or after the experimental flood releases in 2006–2008. Filled circles indicate peak instantaneous discharge (PID) during the flood event. The difference between PIDs and the peak daily mean discharge during the release results from the short duration of each PID (Figure 2).

was followed by a 9.5-year period in which releases rarely exceeded  $1.4 \text{ m}^3 \text{ s}^{-1}$  (Figure 3). That period of relatively uniform base flow included May 2002, when we censused beaver dams and estimated pond extent. A 3-day flood release in 1998 featured  $Q_{\text{MAX}} = 18.4 \text{ m}^3 \text{ s}^{-1}$ , and a 5-day release in 2001 featured  $Q_{\text{MAX}} = 8.9 \text{ m}^3 \text{ s}^{-1}$ . The downstream gauge recorded three small natural flash floods between early 1995 and 2004: in September 1995 ( $Q_{\text{MAX}} = 8.5 \text{ m}^3 \text{ s}^{-1}$ ), in August 2001 ( $1.9 \text{ m}^3 \text{ s}^{-1}$ ), and in September 2002 ( $1.3 \text{ m}^3 \text{ s}^{-1}$ ).

Our level of confidence in identifying dams was ‘very high’ for about half of the dams. We identified 42 beaver dams in our second full census (September 2005), which followed the large ( $\sim 200 \text{ m}^3 \text{ s}^{-1}$ ) flood of early 2005 (Figure 3). Our confidence in the identification was rarely ‘very high’, however, and most (68%) of the mainstem dams were concentrated in one valley (Lincoln Ranch). The ground observations made in December 2005 confirmed the presence of two of those dams at each of ALR and PC, and confirmed the absence of dams at MW and in the 3-km-long reach immediately above the cluster of PC dams. Thus, functioning, presumably active dams were again present on at least two river reaches only 5 months after cessation of large floods (Figure 3).

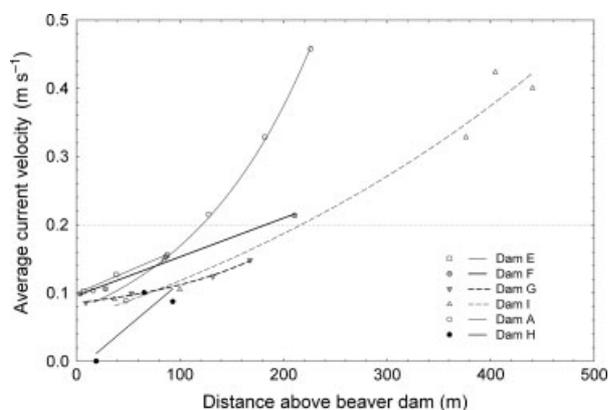
Figure 4. The relationship between average current velocity ( $V_{AVE}$ ) in a beaver pond and the distance above the dam for reach PC. The lines represent linear and exponential models used to estimate the distance ( $K_T$ ) at which  $V_{AVE} = 0.2 \text{ m s}^{-1}$ , the threshold velocity separating lentic and lotic habitat (horizontal dashed line).

Our analyses produced both linear and exponential models relating  $V_{AVE}$  to distance above the dam (Figure 4). Adjusted  $r^2$  values were generally high in both model sets; the lowest  $r^2$  among the five models judged significant ( $P \leq 0.082$ ) was 0.94. The data for Pond PC-H (Figure 4) failed to produce a significant model, so we fit the exponential model developed for the similar and nearby Pond PC-G (Figure 4) to the non-zero  $V_{AVE}$  data for Pond PC-H to estimate  $K_T$  there. The values of  $K_T$  derived from the models ranged from 121 to 229 m. In those cases where estimation of  $K_T$  required extrapolation beyond the data (i.e. all measured values of  $V_{AVE}$  were  $< 0.2$ ), we judged the  $K_T$  values to be realistic (Figure 4).

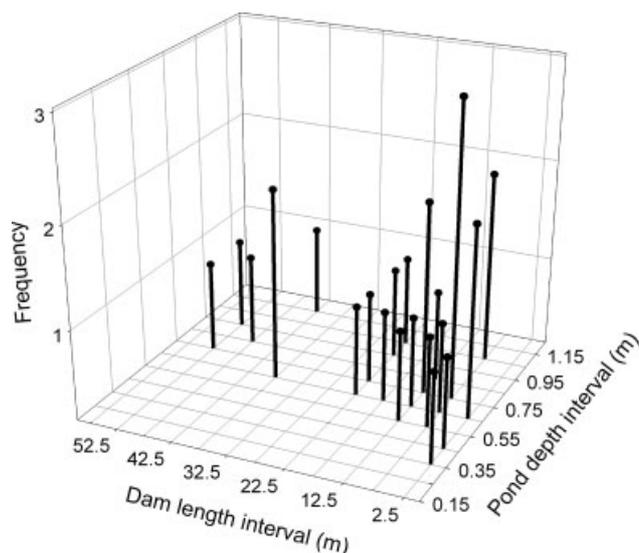
Figure 5. Bivariate frequency distribution for dam size variables  $D_{MAX}$  (maximum impoundment depth near the dam, grouped in 0.1-m intervals) and  $L$  (dam length along crest, grouped in 5-m intervals) for 27 dam/pond complexes examined along the Bill Williams River prior to the 2008 experimental flood. Frequencies are plotted at midpoint value for each interval.

(Shapiro–Wilk test for normality,  $P = 0.58$ ). More than half had maximum depths  $> 0.6 \text{ m}$  and  $\leq 0.8 \text{ m}$  (mean  $D_{MAX} = 0.75 \text{ m} \pm 0.035$  (SE)). Dam lengths were not normally distributed ( $P < 0.001$ ), but could be represented by a lognormal distribution (Shapiro–Wilk test on  $\log L$  values,  $P = 0.25$ ). Based on these results, we generated a bivariate frequency distribution matrix for the 27 measured dams using a 0.1-m increment for  $D_{MAX}$  and a 5-m increment for  $L$  (Figure 5).

Application of the observed bivariate distribution matrix (Figure 5) to the 2008 population of 91 dams and calculating the  $K_T$  value for each associated pond (using the multiple regression equation applied to each size-class cell and scaling up by frequency) produced an estimate of 11.6 km of lentic habitat in the associated beaver ponds. Analogously, the 104 ponds present in 2002 produced 13.2 km of lentic habitat, representing  $\sim 23\%$  of the river's total length. Assuming that 5% (2.9 km) of the BWR was lentic habitat due to natural (abiotic) geomorphic features present after the 1995 floods, when no beaver ponds existed, our analysis indicates beaver were shifting aquatic habitat from lotic to lentic at the average rate of 3.4% per year during 1995–2002.

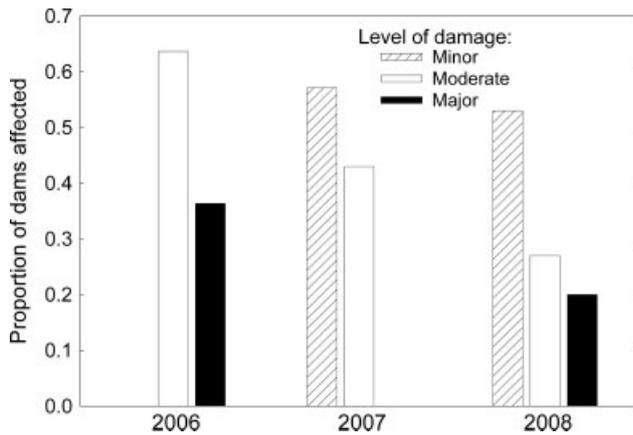
Figure 6. Proportions of monitored dams in each of three damage classes following the spring flood pulses on the BWR. Major damage includes breaches  $>3$ -m wide. Moderate damage includes all breaches  $<3$ -m wide. Minor damage includes loss of some dam component materials and increased leakiness, but little loss of dam functionality. Sample sizes were 11, 7, and 86 for 2006, 2007, and 2008, respectively.

Of the 48 dams monitored via videography, 8 suffered major damage, 16 moderate damage, and 24 were judged to have suffered at most only minor damage (Figure 6).

The proportions in the three damage categories were equivalent in the ground and aerial assessments (Pearson chi-squared test,  $P = 0.28$ ). Based on the pooled data sets, the 2008 release caused major damage to 20% of the BWR beaver dams (Figure 6).

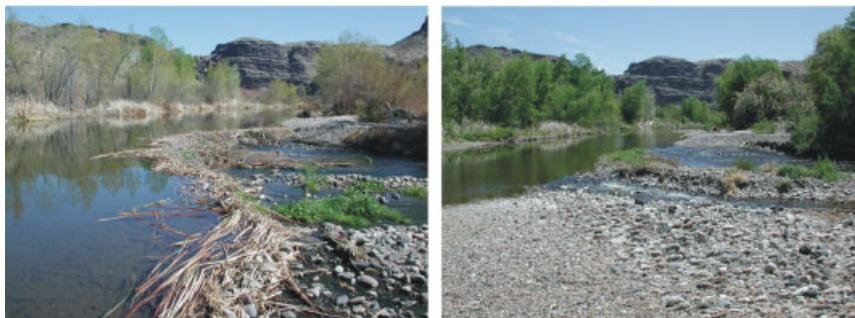
Figure 7. (Left panel) A 33-m-long dam (ALR-D) on the upper Bill Williams River on 22 February 2006, just prior to the 13 March flood release. (Right panel) Same location on 26 April, 5 weeks following the flood release. The site remained unoccupied for at least a year. A replacement dam, constructed sometime between April 2007 and March 2008, was removed by the 2008 flood pulse.

resulted in complete destruction of three of the four dams at ALR and one of the seven at PC. All other dams suffered moderate damage, including breaches that resulted in pond drainage (Figure 6). At ALR, the three upstream dams were completely washed away (Figure 7), whereas the lower most dam retained some functionality and appeared to be under repair or redevelopment when the site was revisited  $\sim 1$  month post-flood. The presence of beaver, solely at the lowest dam, was confirmed at the subsequent visit 7 months later (November 2006). Channel geometry at ALR assured that some pool habitat remained at the upstream dam location (Figure 7), but no evidence of beaver activity was noted there.

We documented repair of breached dams and one case of reconstruction at a site (ALR-D; Figure 7) where the 2006 flood pulse had completely removed a dam. The cause of the 1-year long delay in dam replacement is unknown, but could be due to local physical constraints (e.g. an increase in stream power), death or emigration of the resident beaver, or a behavioural choice made by resident individuals. Cook (1943) reported that a colony of beaver maintaining two dams immediately undertook repairs when a July flood 'burst both dams and drained the ponds'. When both dams were again washed out the following March, however, only one received immediate attention, with repair of the other delayed until autumn. Repair of breaches that funnel most or all of the flow through a relatively narrow gap (e.g. Figure 9) may be possible only at very low discharge because of the high stream power otherwise present. The lowest discharge along all reaches of the BWR, given a constant release from Alamo Dam, occurs during summer, when evapotranspiration is the highest. Beaver may be able to initiate dam construction during this 'window' at sites where higher stream power makes it impossible at other times of the year. Townsend (1953) documented the spring washout and subsequent summer reconstruction of numerous beaver dams in a study conducted on the West Fork and upper Clearwater rivers in Montana. In at least one case, a change in colony structure (due to death of an adult) was associated with the absence of repair. Although no discharge data for his study location is available, 1975–1997 data for the lower Clearwater River suggest spring discharges were  $<85 \text{ m}^3 \text{ s}^{-1}$ , and perhaps much less. Rutherford (1953) noted that, in Colorado, beaver initiated work in March or April to replace dams destroyed in a  $283 \text{ m}^3 \text{ s}^{-1}$  flash flood that had occurred late in the previous summer.

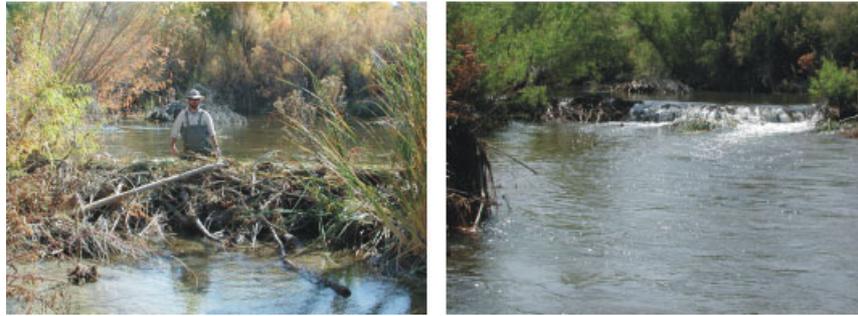
Figure 8. (Left panel) View of Dam PC-D from its tailwater on 30 November 2006. (Right panel) Dam PC-D being overtopped by floodwaters associated with the  $37 \text{ m}^3 \text{ s}^{-1}$  April 2007 release. The image, captured  $\sim 24$  h after flood recession was initiated at Alamo Dam, shows the water surface elevation in the pond behind the dam  $\sim 30$  cm below the peak stage reached during the flood but still  $\sim 20$  cm higher than the pre-flood stage, which was similar to the level depicted in the left panel. This dam was also overtopped during the 2008 flood pulse, but again functionality was only slightly diminished.

The floodwaters overtopped all dams at PC, but none had clearly suffered major damage when last observed during the middle stage of flood recession. Dam PC-D (Figure 8), which was noted to have been partially breached at its right abutment by the previous flood, was again partially breached at that point. Dam PC-E was breached in its centre ( $<3$ -m breach = moderate damage).

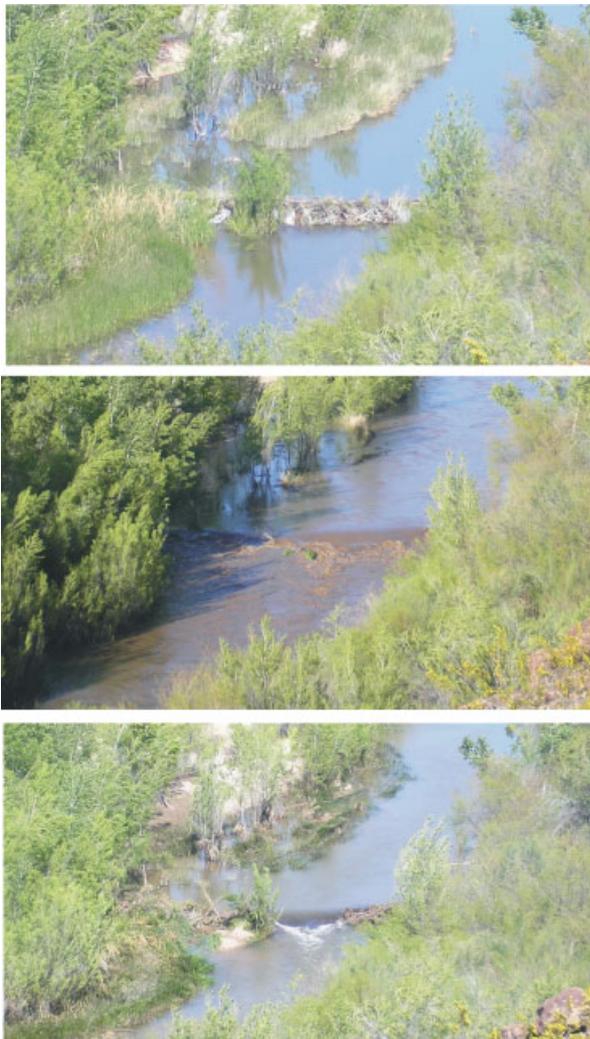
Figure 9. Repeat photographs showing Dam PC-G a few hours prior to arrival of the 2008 flood pulse (top panel) and being overtopped by that pulse (middle panel). The dam suffered a central 3.9-m breach (= major damage) that lowered the pond's surface elevation (bottom panel), but retained some functionality based on the 40-cm drop through the breach present  $\sim 2$  days post-flood. Photographs by Brad Cannon and Tom Liptrott, US Bureau of Land Management.

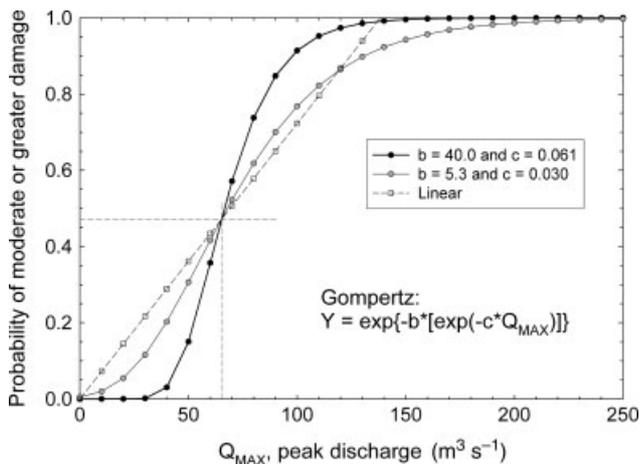
Figure 10. Three possible general models, applicable to the entire BWR, for the relationship between  $Q_{MAX}$  during a controlled flood and the probability of a beaver dam suffering at least moderate damage (a breach). All models were parameterized using the 2008 results (47% of the dams at least moderately damaged by a  $65 \text{ m}^3 \text{ s}^{-1}$  peak release; dashed grey lines) and  $\sim 100\%$  of dams being damaged by a  $200 \text{ m}^3 \text{ s}^{-1}$  release. The sigmoid models are Gompertz equations parameterized as noted in the figure.

It is reasonable to expect a threshold in flood intensity above which the probability of dam failure

rapidly increases. Flood intensity, however, has multiple independent components, including the rate of rise to  $Q_{MAX}$ ,  $Q_{MAX}$  itself, the duration of flow at or near  $Q_{MAX}$ , and the form of fluctuations around  $Q_{MAX}$  (i.e. multiple flow peaks). How these components affect the probability of dam failure is unclear. Shafroth *et al.* (2010) suggested a sigmoidal model for linking  $Q_{MAX}$  to dam failure. Figure 10 presents two such models as well as a linear model fit to the data point produced by our most extensive data set, the 2008 results, and low failure probability at low discharge and a maximum at  $Q_{MAX} \leq 200 \text{ m}^3 \text{ s}^{-1}$ . Although speculative, the models point to the heuristic value of assessing effects of a flood with  $Q_{MAX} \sim 40 \text{ m}^3 \text{ s}^{-1}$ , where model probabilities differ greatly and experimental cost (in terms of water released) is relatively small. The hydraulic and fluvial geomorphic processes that lead to beaver dam failure are also involved in reshaping channel beds and banks. River scientists have long recognized that the ability of a stream to do work (e.g. move bed sediment) increases with discharge, but this ability, termed stream power, is also affected by water depth and other variables linked to channel geometry. Costa and O'Connor (1995) argued that flood duration as well as  $Q_{MAX}$  determined the amount of geomorphic work that actually takes place, and suggested that total (= cumulative) stream power over the duration of a flood (= total energy expended during the flood) is the best indicator of a flood's geomorphic effectiveness. If so, models relating dam failure probability to cumulative stream power may prove most insightful.
