**STREAMFLOW AND SEDIMENT DYNAMICS OF THE
MIDDLE RIO GRANDE VALLEY, NEW MEXICO,
IN THE CONTEXT OF COTTONWOOD RECRUITMENT**

**Technical Report
10 March 1993**

**U.S. Fish and Wildlife Service
National Ecology Research Center
4512 McMurry Avenue
Fort Collins, Colorado 80525-3400**

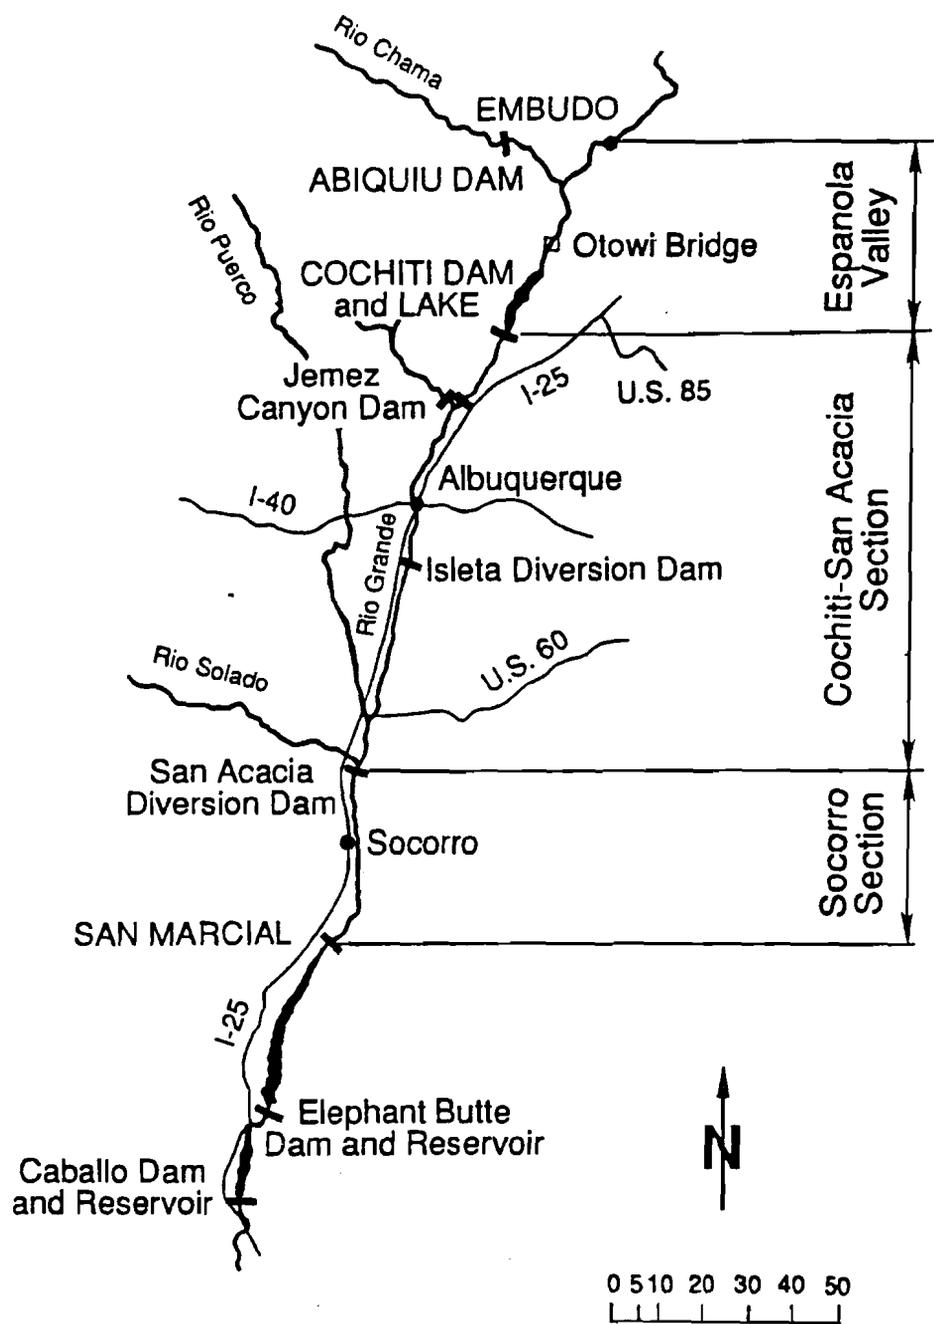
Fig. 1. Reaches, divisions, dams, and diversions along the Middle Rio Grande within the study area (from U.S. Bureau of Reclamation 1977).

The MRG, as used in this report, extends from the lower end of the Taos Plateau to the headwaters of Elephant Butte Reservoir, between the U.S. Geological Survey (USGS) gages at Embudo (about 5 miles upstream of Velarde) and San Marcial (Fig. 1).

The MRG water resource system from Velarde to Elephant Butte Reservoir can be divided into three major divisions and six reaches (Fig. 1). Tributaries with drainage areas in excess of 500 mi² include the Rio Chama, Rio Galisteo, Jemez River, Rio Puerco, and Rio Salado; a brief description of each of these major tributaries can be found in U.S. Army Corps of Engineers (1989). The Rio Grande and its major tributaries within the project area are regulated by six main reservoirs (El Vado, Heron, Abiquiu, Jemez Canyon, Cochiti, and Elephant Butte) and many smaller ones.

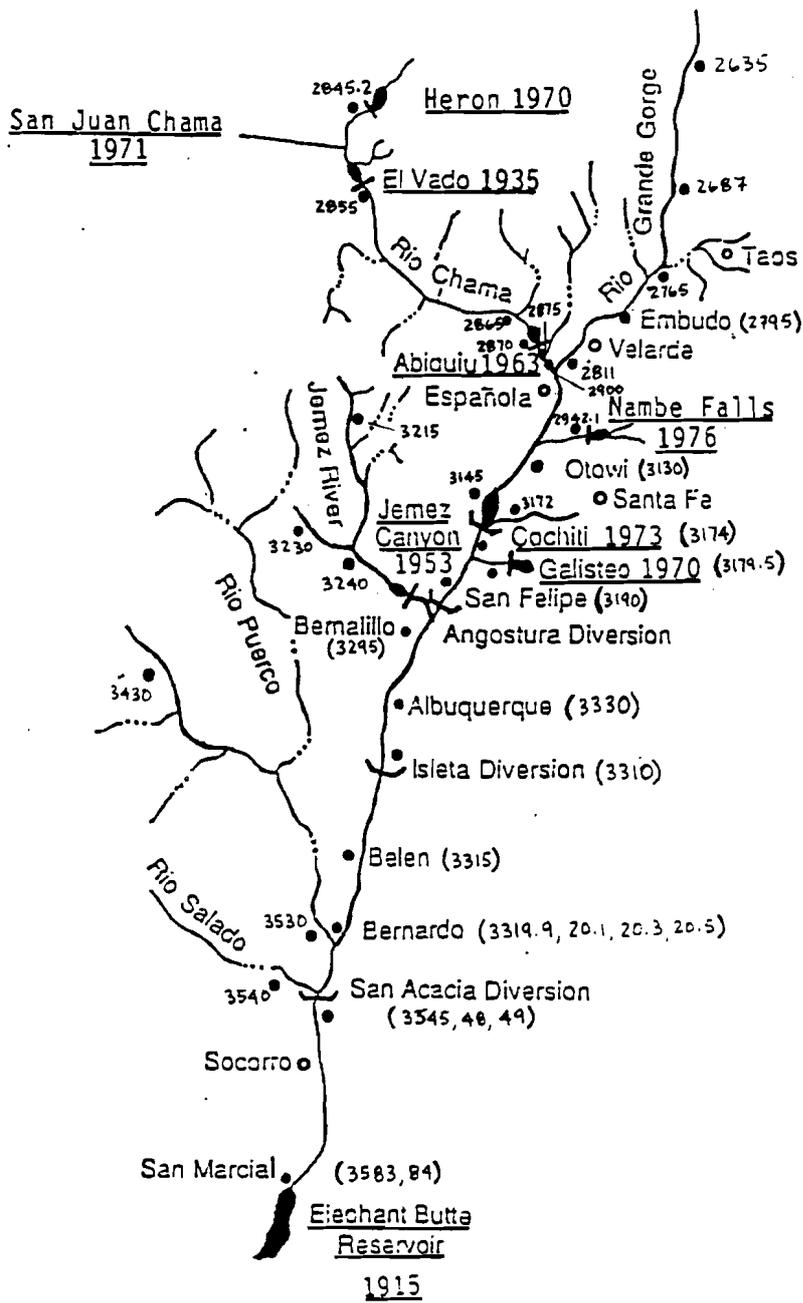
Fig. 3. U.S. Geological Survey gaging stations on the Middle Rio Grande and its major tributaries.

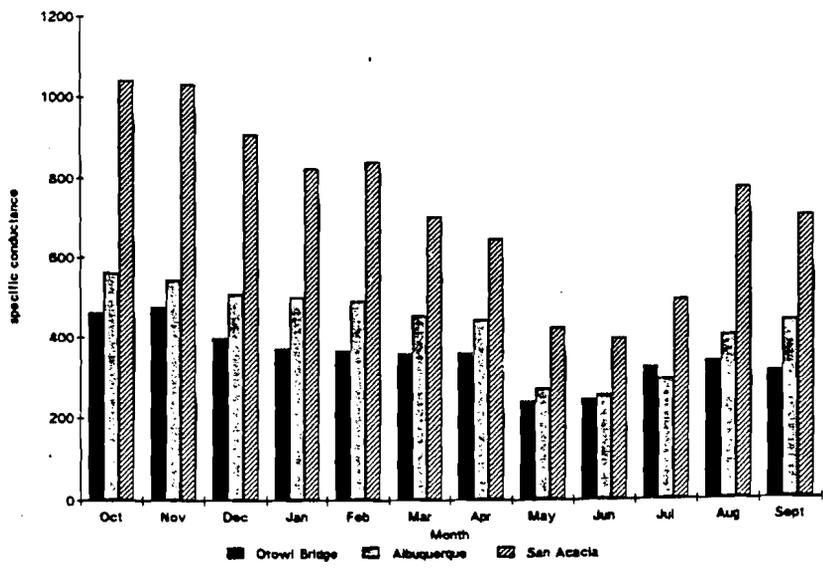
Fig. 4. Specific conductance in the Middle Rio Grande for water year 1975.

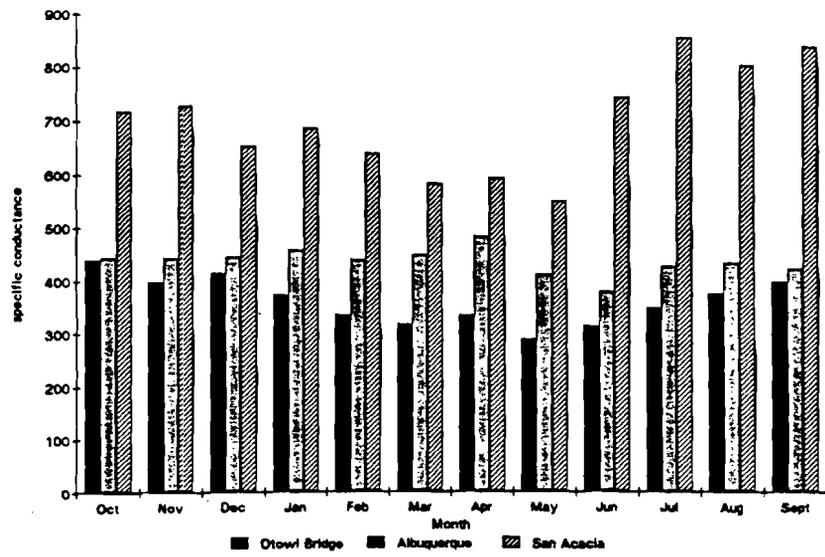
Fig. 5. Specific conductance in the Middle Rio Grande for water year 1990.

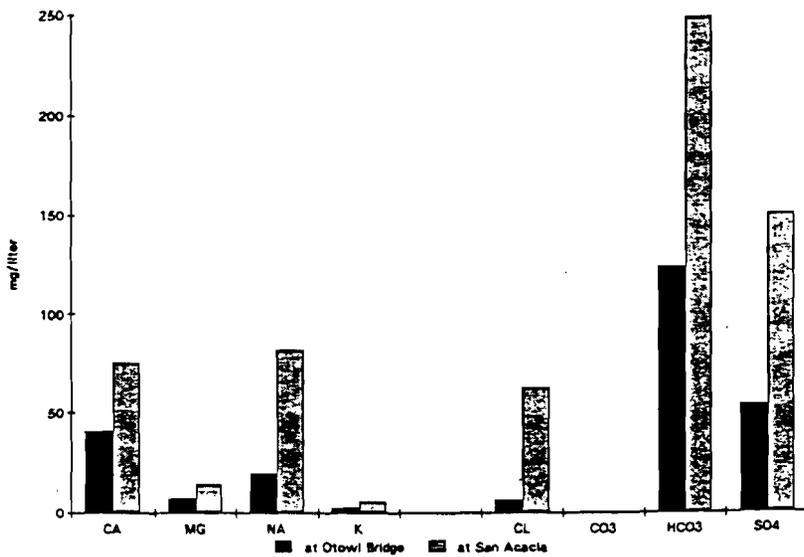
Fig. 6. Major constituents of dissolved solids in the Middle Rio Grande. Data for Otowi bridge were obtained on August 22, 1990, and for San Acacia on September 6, 1990.

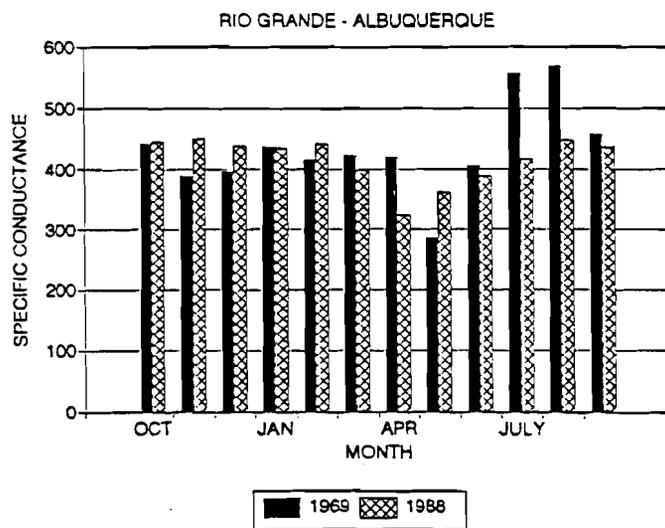
Fig. 7. Specific conductance measured at the Albuquerque gaging station.

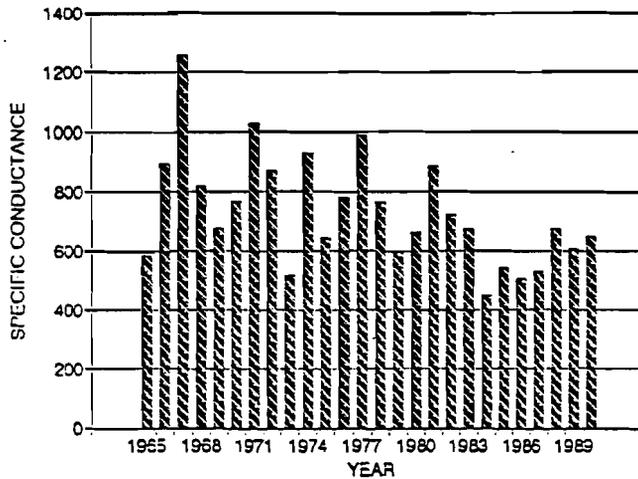
Fig. 8. Specific conductance measured at the San Marcial floodway gaging station.

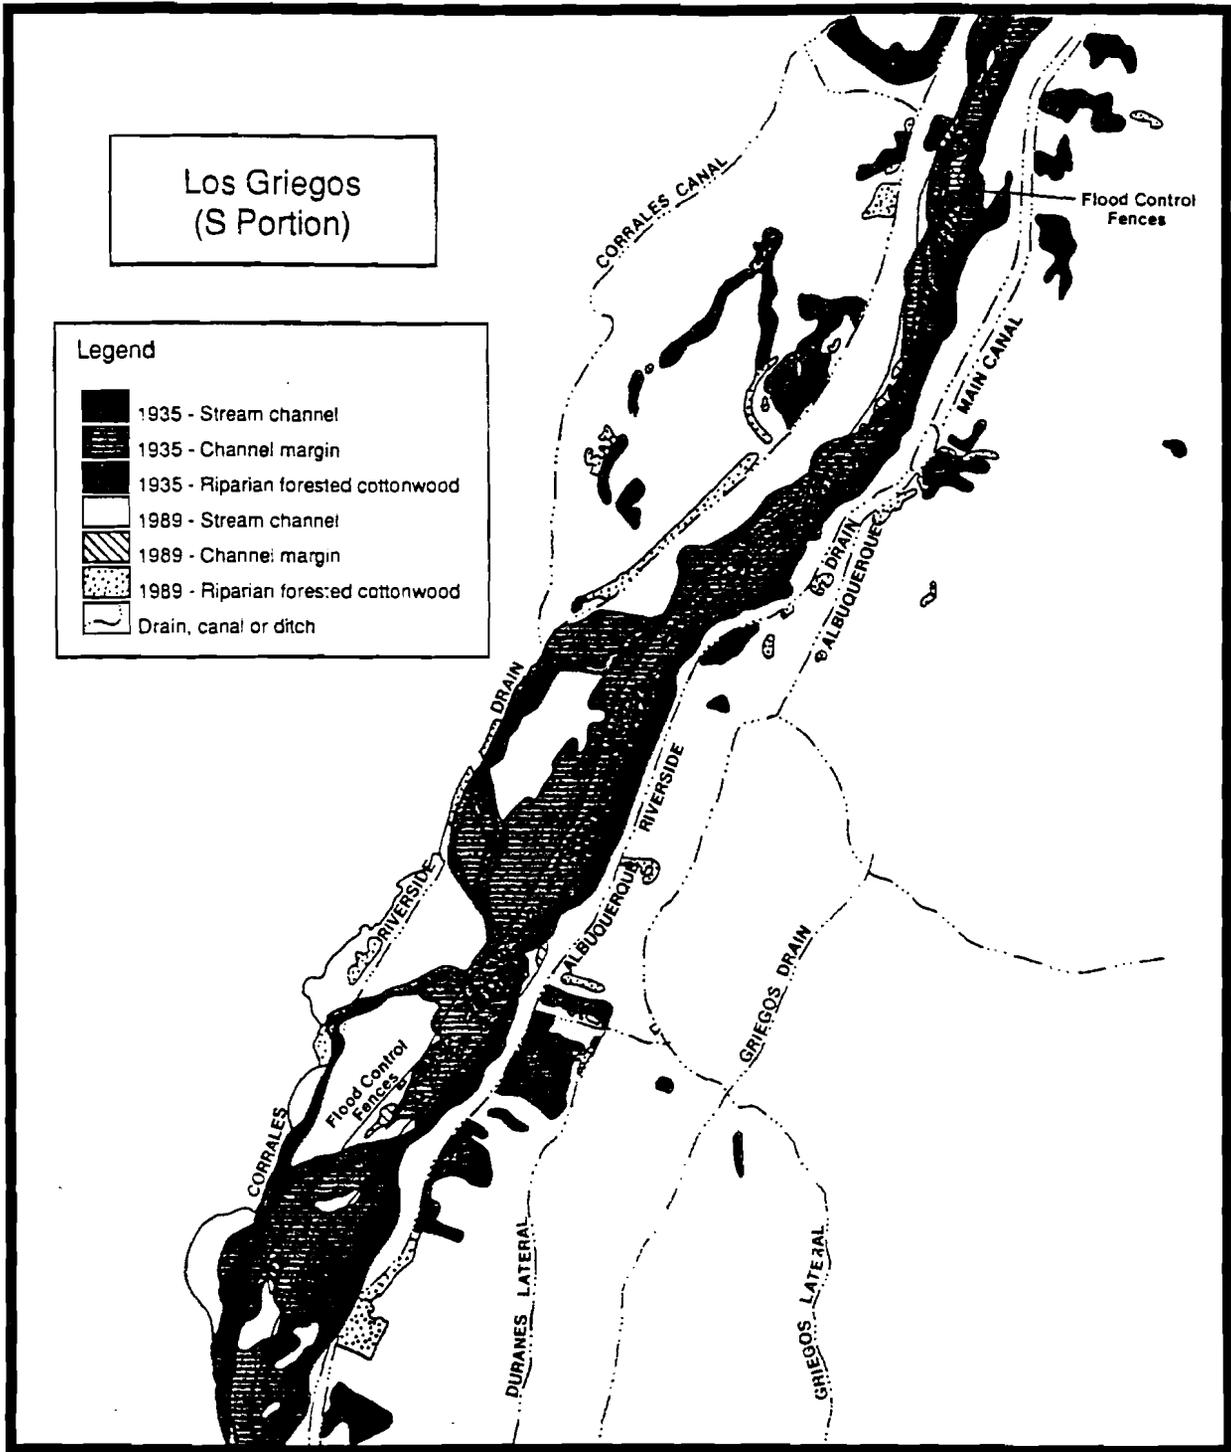
Fig. 12. Comparison of the planforms of the Rio Grande in the Los Griegos area in 1935 and 1989.

Most of the work done in the San Felipe to Albuquerque to reach was in the southern portion between Bernalillo and Albuquerque. Planform changes between 1935 and 1989 were investigated for a reach from Los Griegos to Albuquerque, a distance of approximately 10 river miles. This reach is bounded on both sides by levees which restrict and limit movement of the river to a zone approximately 1,500 feet wide in the vicinity of Albuquerque. Figures 12 and 13 compare the Rio Grande planform in 1935 and 1989 near Los Griegos and Albuquerque. In addition, these figures also show locations of cottonwood groves. The streambed in 1989 was much straighter and narrower than in 1935. The river is no longer able to move as freely as it used to because of the levees. In 1935 the river also had a much wider floodplain than in 1989. The 1989 floodplain has been overgrown with riparian vegetation.

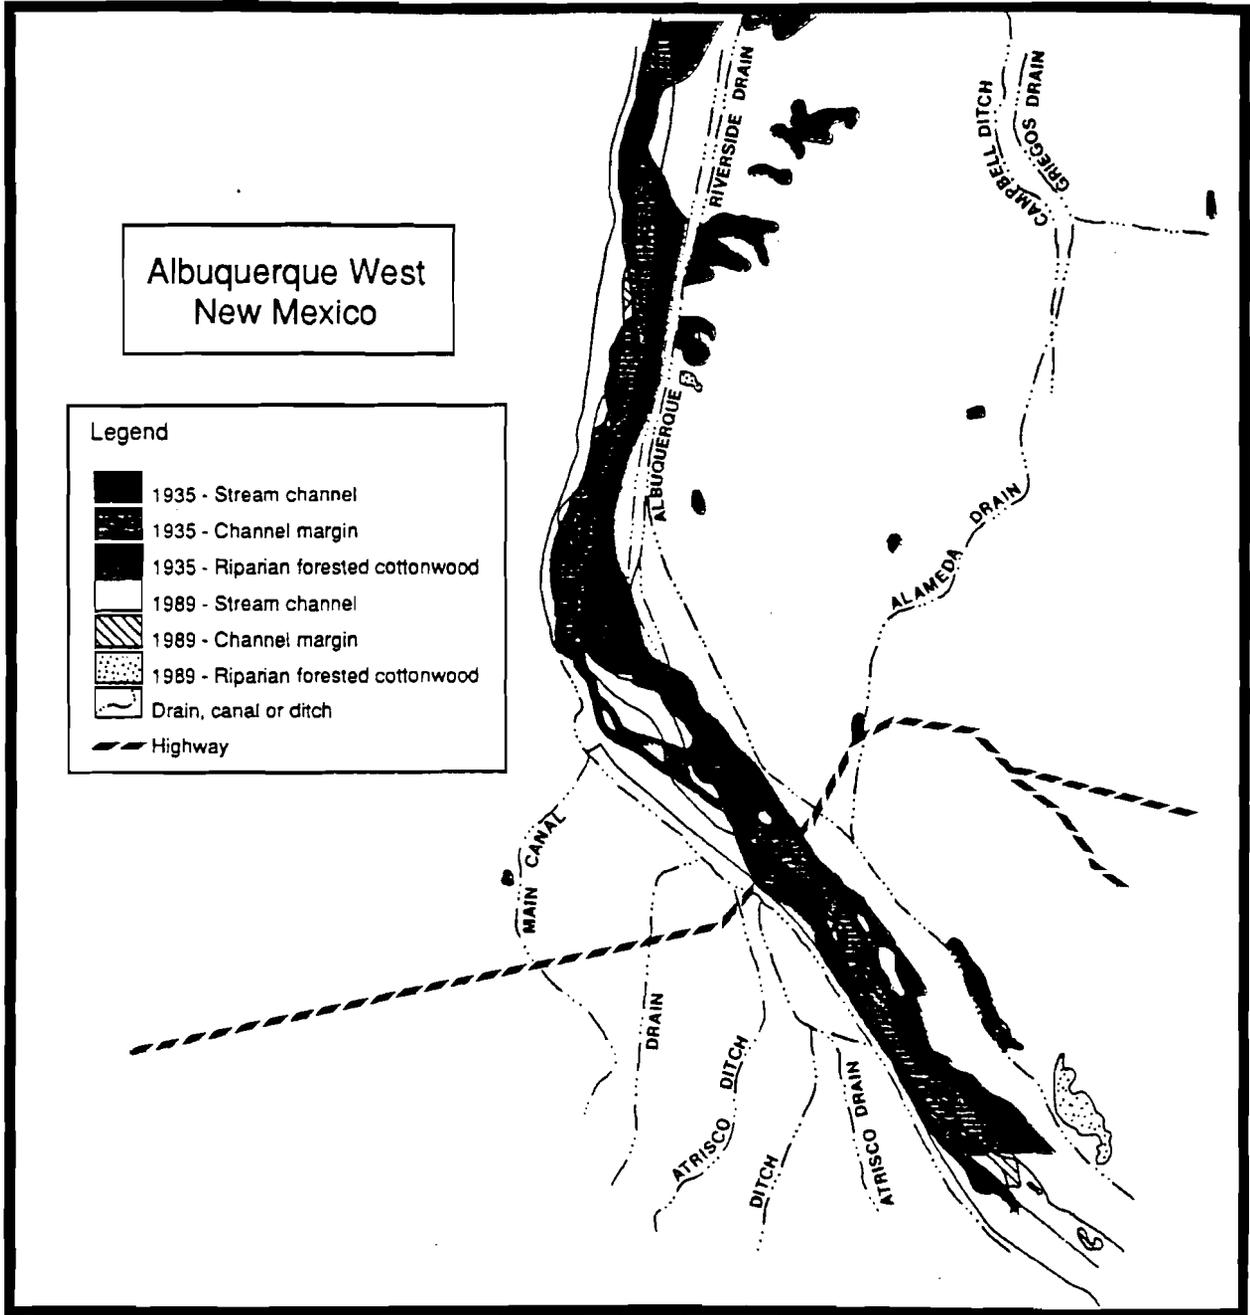
Fig. 13. Comparison of the planform of the Rio Grande in the Albuquerque area in 1935 and 1989.

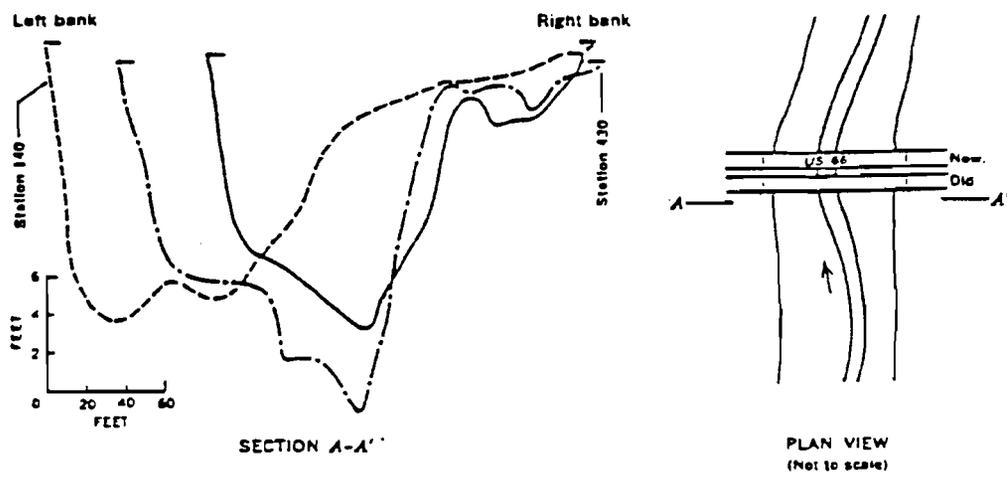
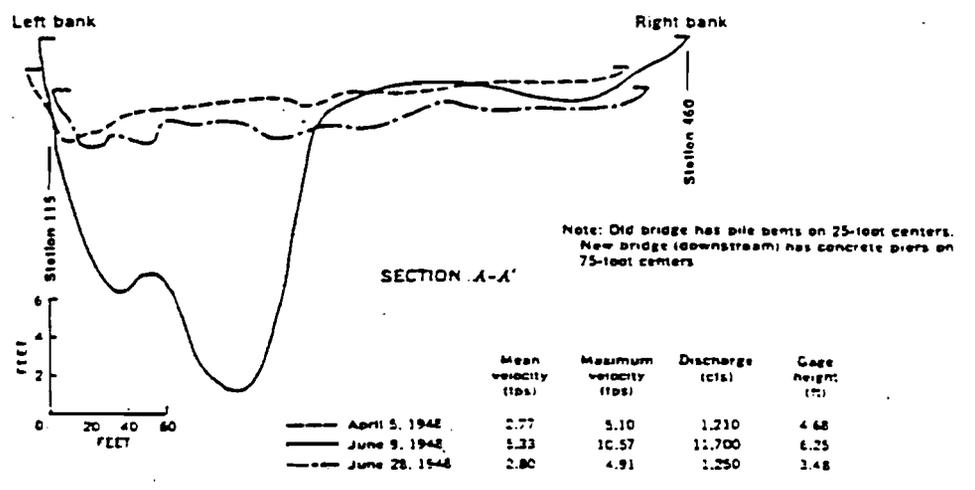
Mean velocity (fps)	Maximum velocity (fps)	Discharge (cfs)	Gage height (ft)
— April 6, 1942	3.85	8.82	6,930	4.87
- - - May 2, 1942	3.44	7.94	8,490	4.37
- · - May 15, 1942	4.85	11.33	13,900	5.09

Mean velocity (fps)	Maximum velocity (fps)	Discharge (cfs)	Gage height (ft)
— April 5, 1942	2.77	5.10	1,210	4.68
- - - June 9, 1942	5.33	10.57	11,700	6.25
- · - June 28, 1942	2.80	4.91	1,250	3.48

Fig. 14. Shift of the thalweg and local scour during flood flows, Rio Grande at Albuquerque, New Mexico.

The Rio Grande is a braided sandbed river. Without the levees the river would be very migratory in nature. Figure 14 illustrates lateral and vertical changes in the river near Old Town, Albuquerque, for a period in 1942 and 1948 (Culbertson et al. 1967). Note, however, that this figure describes a channel that no longer exists because of channel stabilization works.

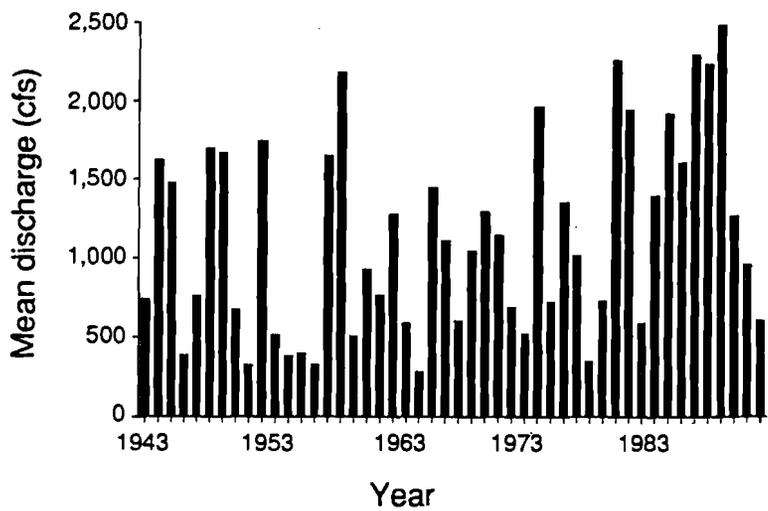
Fig. 15. Mean annual discharge of the Rio Grande at Albuquerque, New Mexico, water years 1943-1990.

Mean annual discharge of the Rio Grande has been impacted by evaporation from reservoir pools, transbasin diversions into the Rio Grande basin, and changes in consumption within the basin (Fig. 15). However, these impacts are minor relative to the impacts on peak flows and sediment flows (Figs. 16 and 17).

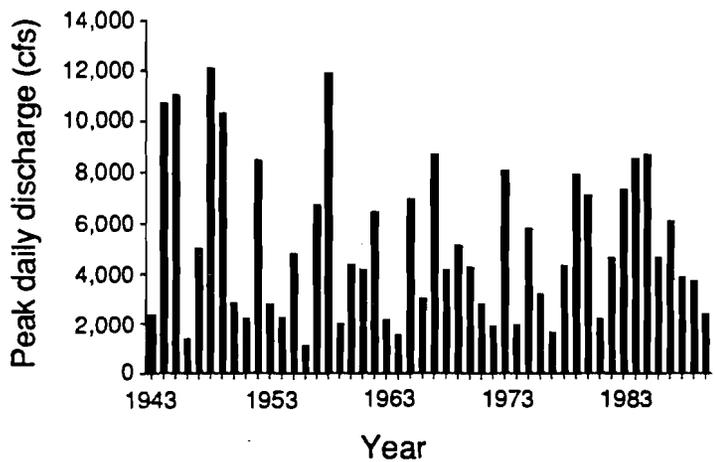
Fig. 16. Peak discharge of the Rio Grande at Albuquerque, New Mexico, water years 1943-1990.

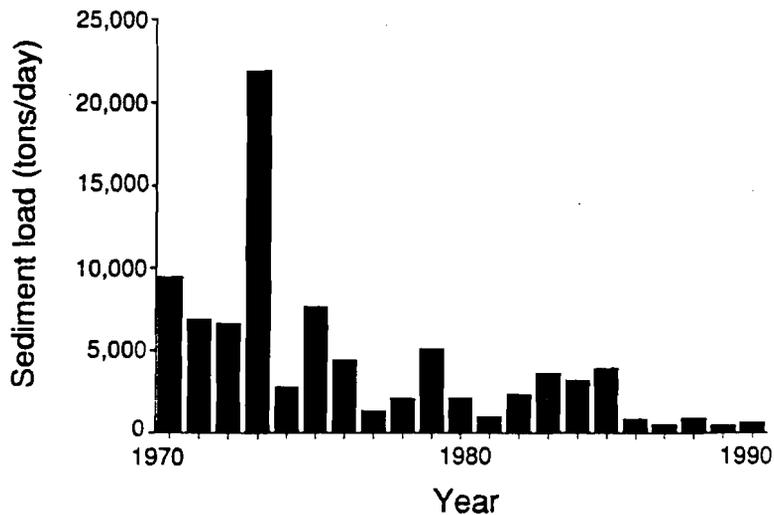
Fig. 17. Measured sediment load for the Rio Grande at Albuquerque, New Mexico, water years 1970-1990.

Calculated sediment loads were used to develop the above equation, whereas the data in Fig. 17 represent measured sediment load. The difference between these two quantities is small for many streams, but for the Rio Grande it is significant (Fig. 20) with measured annual sediment yield often 70% to 80% of the total load.

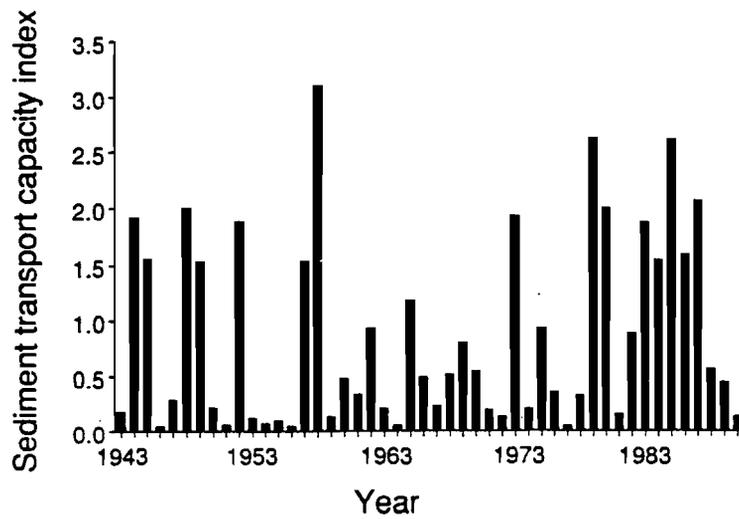
Fig. 18. Sediment transport capacity index for the Rio Grande at Albuquerque, New Mexico, water years 1943-1990. (Reference discharge of 2,000 cfs and critical discharge of zero.)

The annual sediment transport capacity index time series (Fig. 18) suggests that the river still has considerable capacity to transport sediment, but the measured sediment load data (Fig. 17) indicate a significant reduction in yield. A graph of sediment yield versus sediment transport capacity index indicates that the reservoirs have reduced yield significantly (Fig. 21). This also should have resulted in a reduction in bed elevations, which Lagasse (1981) indicates is the case for the period up to 1980, except where base level is controlled by a structure or by gravel deposited in the channel.

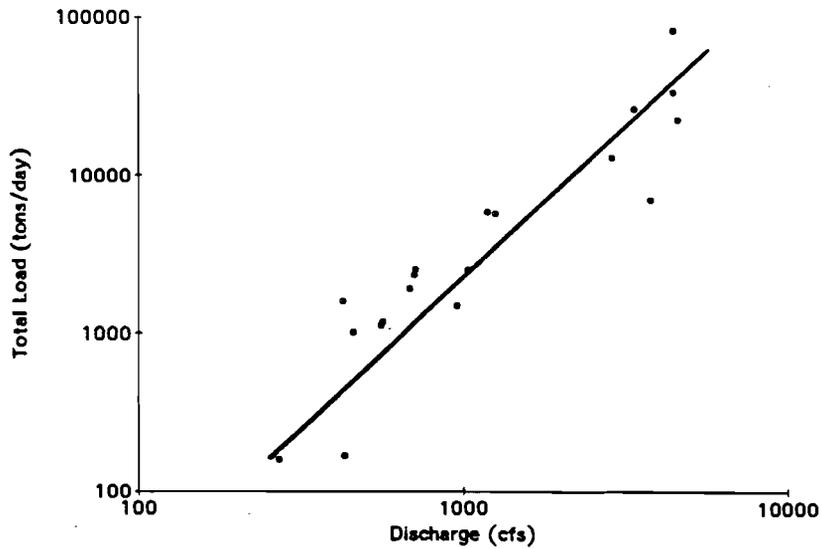
Fig. 19. Discharge versus total sediment relation for the Rio Grande at Albuquerque, New Mexico, water year 1975.

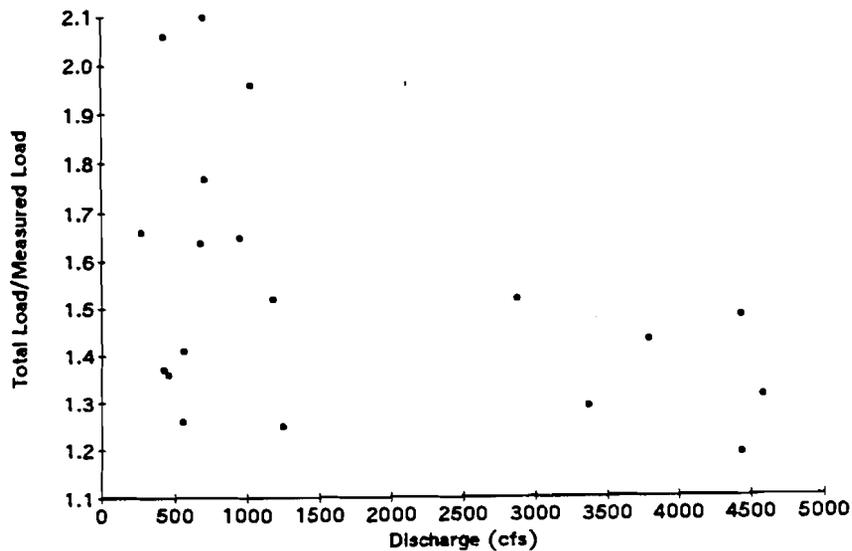
Fig. 20. Ratio of total sediment load to measured sediment load versus discharge for the Rio Grande at Albuquerque, New Mexico, water year 1975.

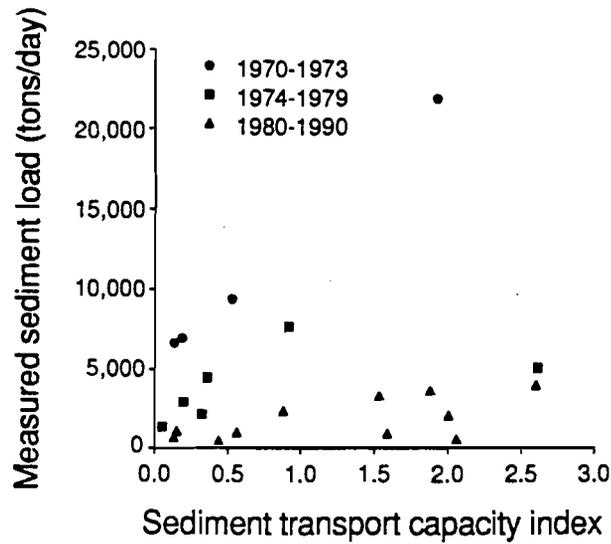
Fig. 21. Relation between measured sediment load and sediment transport capacity index for the Rio Grande at Albuquerque, New Mexico, water years 1970-1990.

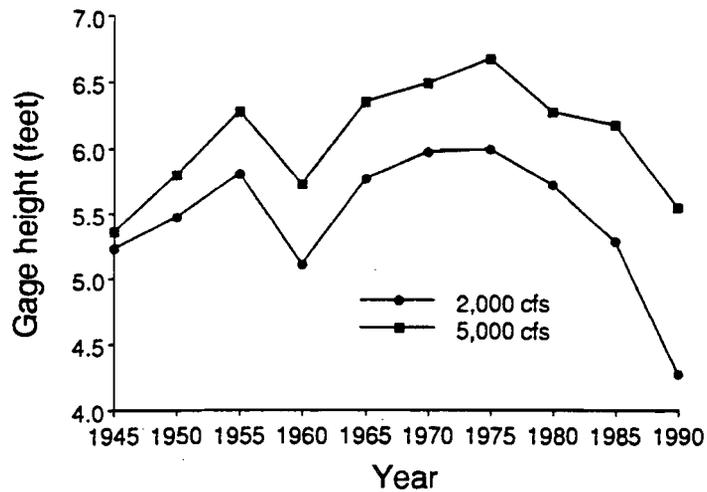
Fig. 22. Change in gage height at the Albuquerque, New Mexico, station between 1945 and 1990.

Figure 22 shows temporal changes in water surface elevation for two flows. Water surface elevations were determined using a stage-discharge relation derived from annual peak flow data. Degradation has probably continued to occur in the Albuquerque area.

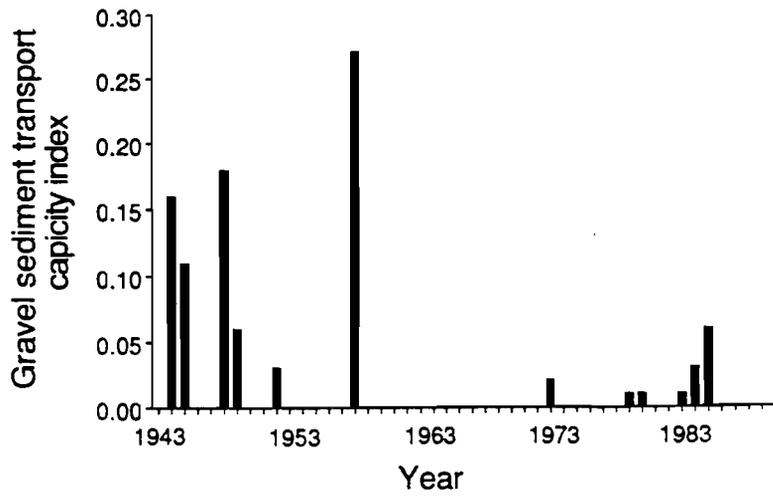
Fig. 23. Gravel sediment transport capacity index for the Rio Grande at Albuquerque, New Mexico, water years 1943-1990. (Reference discharge of 2,000 cfs and critical discharge of 6,000 cfs.)

The capacity to transport gravel has been eliminated except in very wet years (Figs. 23 and 24). Because gravel is found in the sediment we would expect the bed to become paved and the larger material transported to the channel by tributaries to cause nick points (Lagasse 1981). If the period from 1931 to 1990 is considered, the loss of gravel transport capacity may be even more important. Reservoirs have caused part of this change, but part could also be a result of the same climatological processes that have been suggested to have changed the sediment regime in the Paria River (Graf et al. 1991).

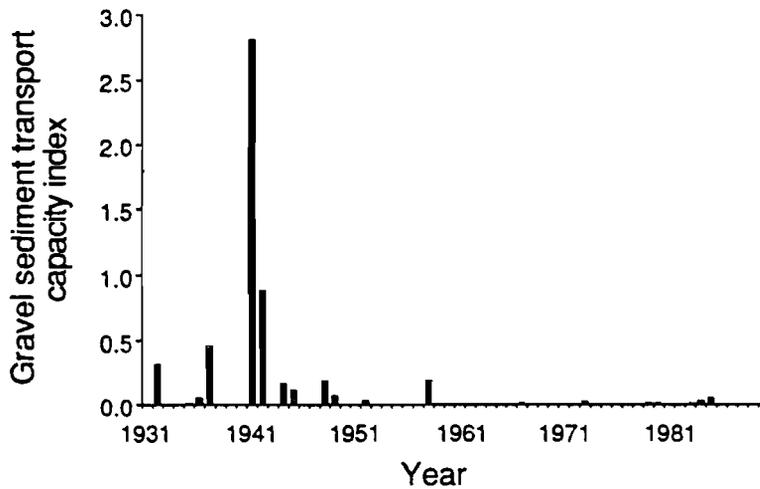
Fig. 24. Gravel sediment transport capacity index for the Rio Grande at San Felipe, New Mexico, water years 1931-1990. (Reference discharge of 2,000 cfs and critical discharge of 6,000 cfs).

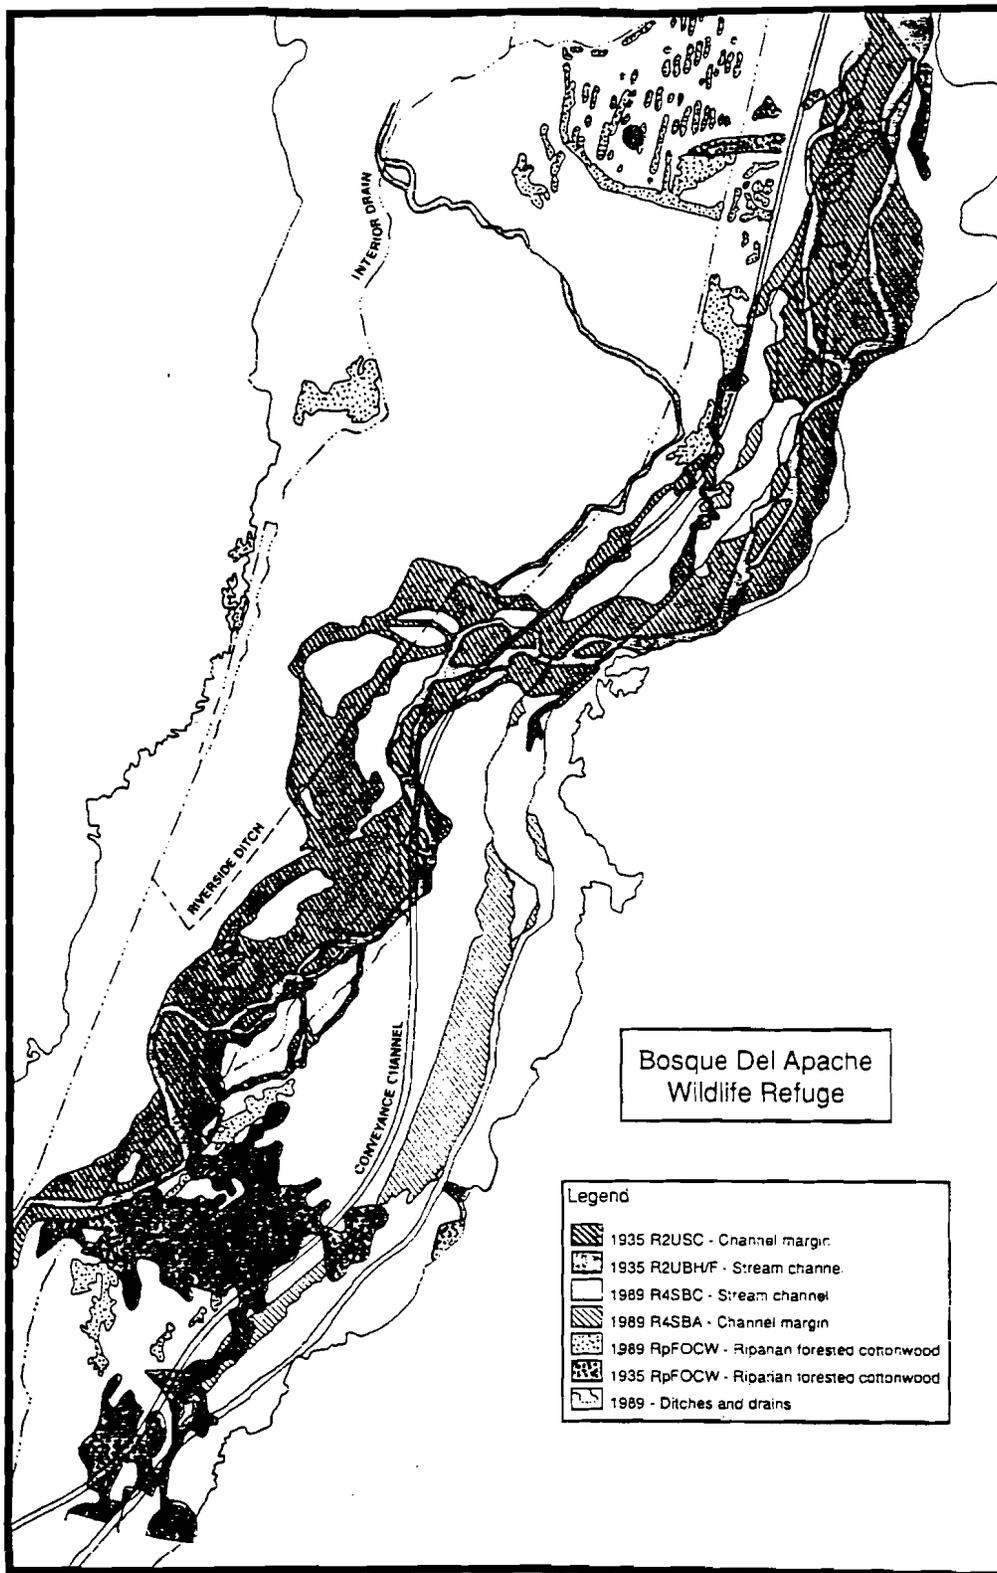
Fig. 25. Comparison of the planforms of the Rio Grande in the Bosque del Apache reach in 1935 and 1989.

There have been very significant changes in the location of the riverbed and thalweg between 1935 and 1989 (Fig. 25). The 1989 channel is much straighter and narrower than the broad, meandering, braided channel of 1935. The river is not as confined as in the reach near Albuquerque because flows have been reduced considerably by the conveyance channel.

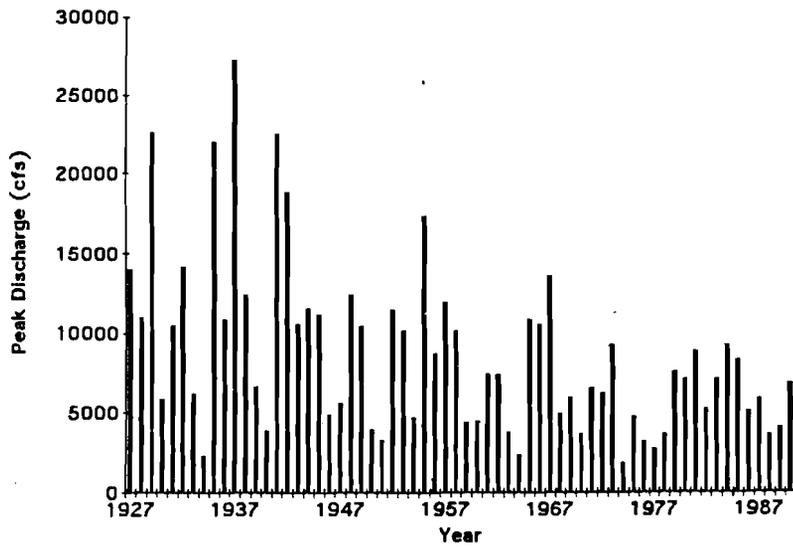
Fig. 26. Instantaneous peak flows at San Felipe, New Mexico, water years 1927-1990.

Peak flows during entire water years (October 1 through September 30) were used in Figs. 26 and 28. However, peak flows needed for scour should occur between April 1 and July 15. Peak daily flows during this period are given in Fig. 29, which is similar in general form to Fig. 27.

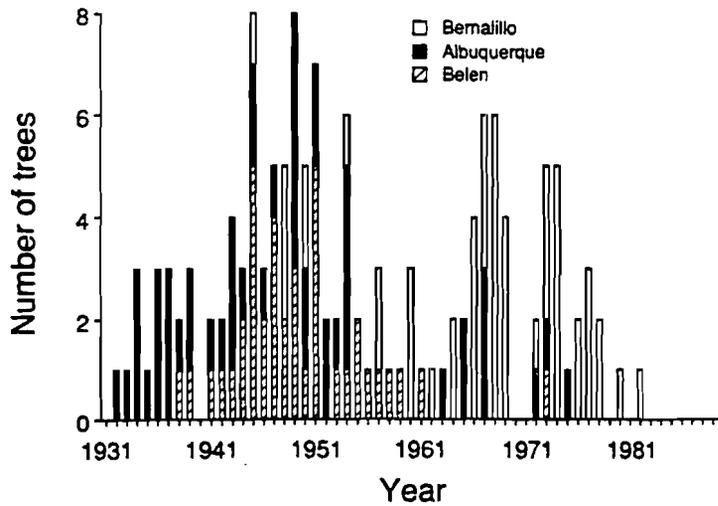
Fig. 27. Establishment dates for cottonwood trees along the Middle Rio Grande. Data from Howe and Knopf (1991).

Howe and Knopf (1991) collected data on cottonwood ages at three sites (near Bernalillo, at Albuquerque, and near Belen) along the Rio Grande (Fig. 27). Trees near Bernalillo were younger than those at the other two sites. The ages in Fig. 27 should not be taken as absolute because of uncertainties in aging cottonwood. There is no clear relationship between age of the trees as determined by Howe and Knopf and the peak discharge measured at San Felipe.

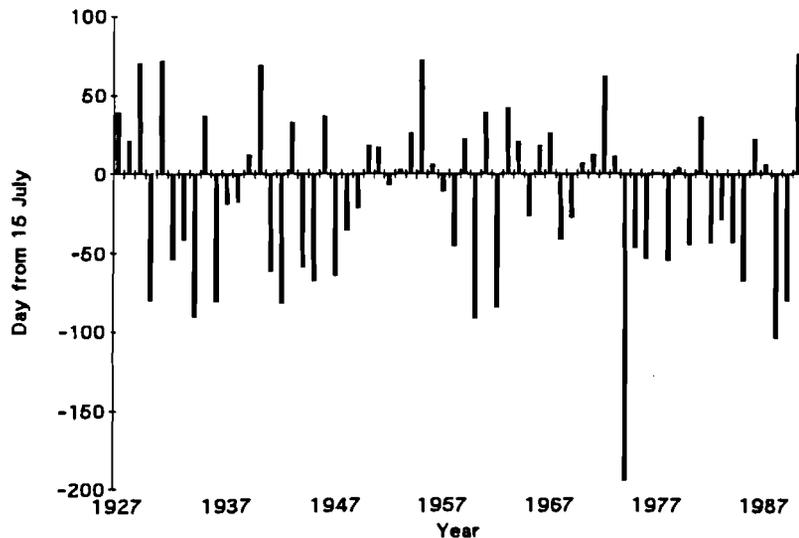
Fig. 28. Timing of peak flows at San Felipe, New Mexico, water years 1927-1990. Negative numbers are days before July 15 in each water year; positive numbers are days after July 15.

One possible cause of a reduction in cottonwood establishment is that reservoirs have delayed peak flows. Timing of the peaks relative to July 15 is given in Fig. 28 for the flows used in Fig. 26. The only anomaly is for water year 1974, when the high flow occurred in the fall and was the lowest of record. Figure 28 suggests that changes in the timing of peak flows have probably not caused a reduction in the establishment of cottonwood seedlings.

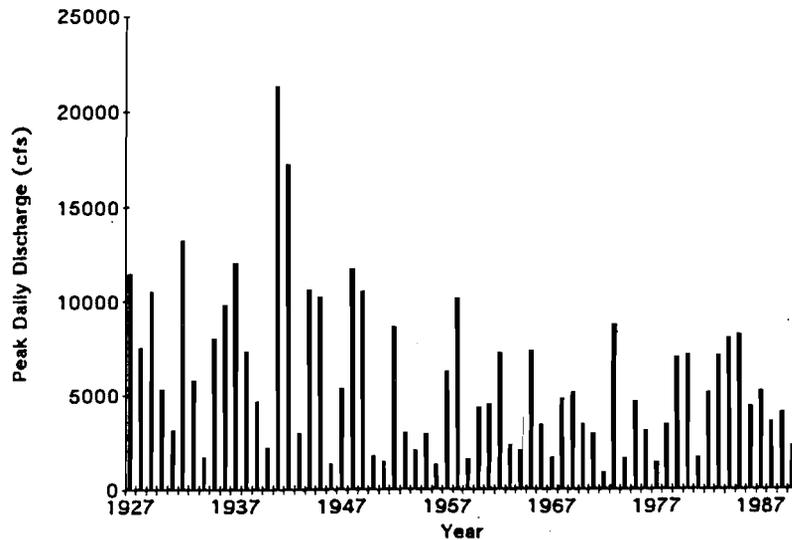
Fig. 29. Maximum daily flows during period April 1-July 15 for the Rio Grande at San Felipe, New Mexico, water years 1931-1990.

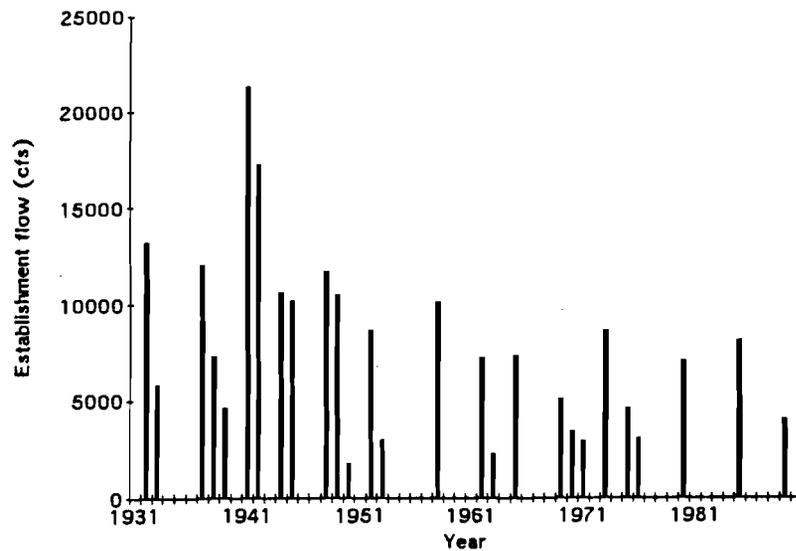
Fig. 30. Annual daily flows based on surviving peak flows for the Rio Grande at San Felipe, New Mexico, water years 1931-1990.

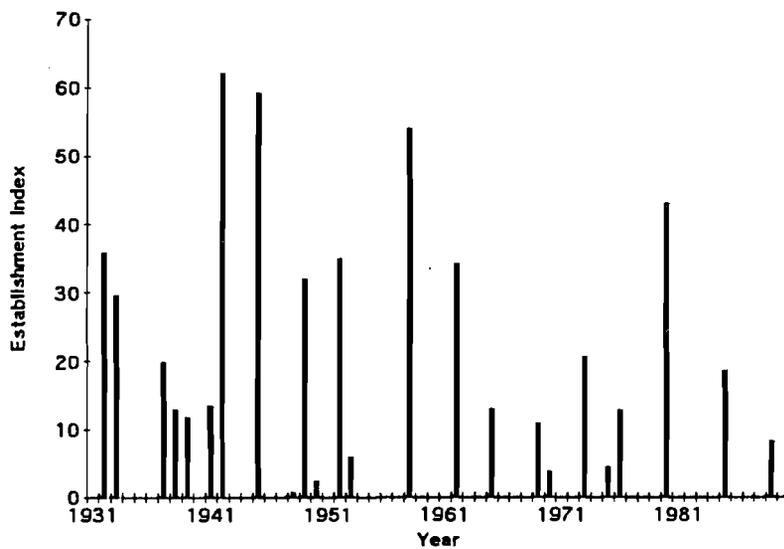
Fig. 31. Annual establishment index based on surviving area for the Rio Grande at San Felipe, New Mexico, water years 1931-1991.

probably been a reduction in the amount and frequency as a result of the reservoir construction (Fig. 31). From 1931 through 1952 the establishment index was 14.4 based on the streamflow data for the gage at San Felipe and 14.0 based on the gage at Embudo (upstream of the reservoirs). From 1975 through 1990, the index was 10.2 at Embudo and 5.4 at San Felipe. Streamflow modifications have reduced the establishment potential by at least 50%.

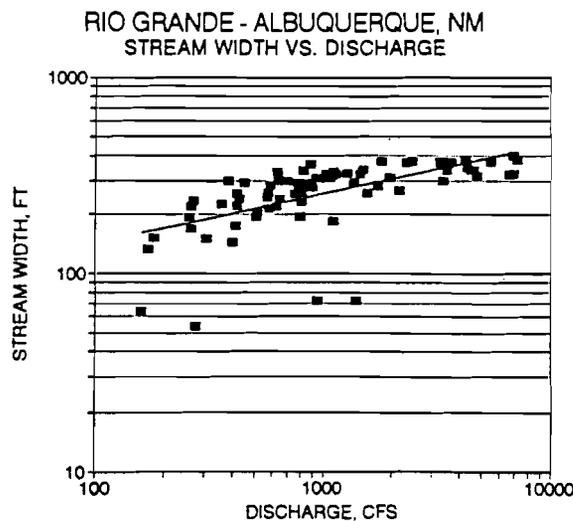
Fig. 32. Stream width as related to stream discharge near Albuquerque, New Mexico. Data for water years 1988-1990. Regression equation is width = 45.19 $Q^{0.2512}$.

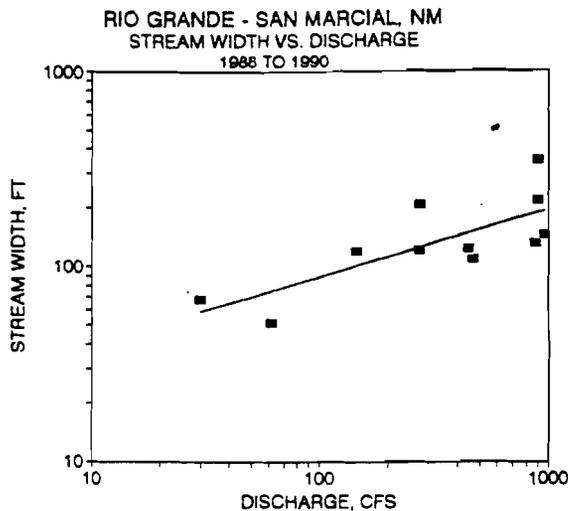
Fig. 33. Stream width as related to stream discharge, near San Marcial, New Mexico. Data for water years 1988-1990. Equation is width = $18.31 Q^{0.34}$.

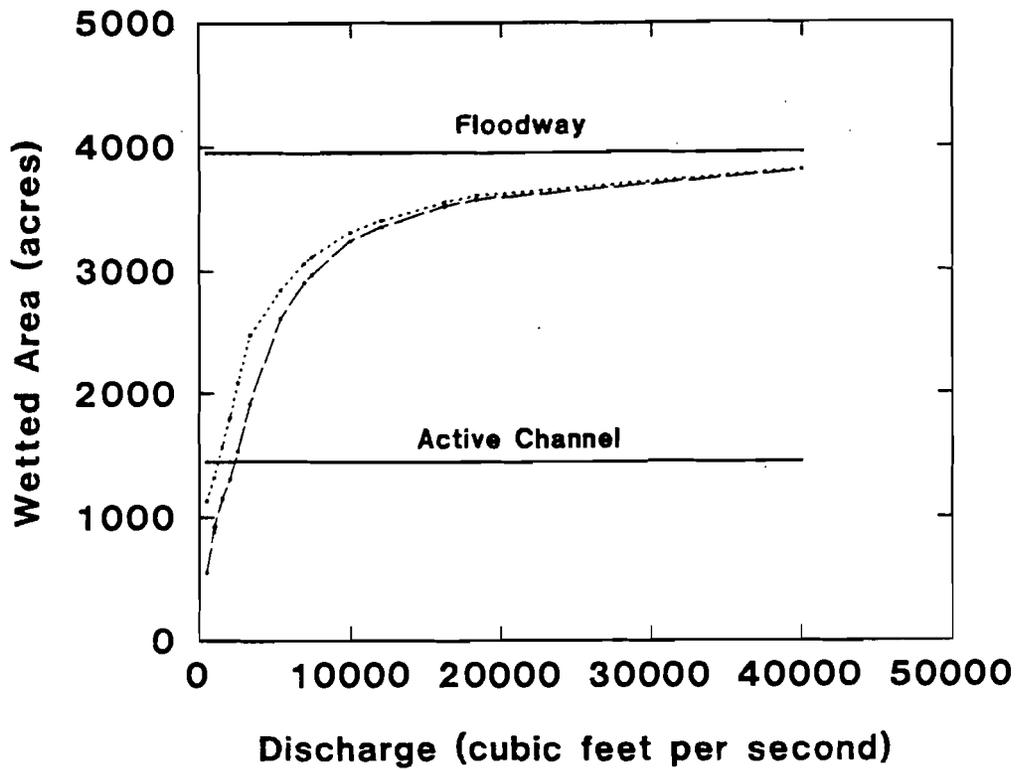
Fig. 34. Wetted area versus discharge function for the Bosque del Apache reach of the Rio Grande. The two lines represent different model assumptions as described in Appendix A.

The final approach was to develop maps of the Bosque del Apache reach showing wetted area at different discharges (Figs. 34 and 35). The techniques and logic used to develop these maps are presented in Appendix A. If cottonwood establishment required only wet substrate, the maps would suffice. Unfortunately, the substrate may also need to be scoured. Velocities and shear stresses in the main channel and the side channels in the vicinity of Bosque del Apache NWR were investigated using HEC-6. The techniques used and details of the results are presented in Appendix B. Because of the dense stands of salt cedar and the existence of the jetty jacks, velocities associated with observed flows for the period 1965-1989 were almost certainly too low to cause scouring (Figs. 36 and 37). The velocity required to cause scouring is not known precisely, but certainly exceeds 1 foot per second.

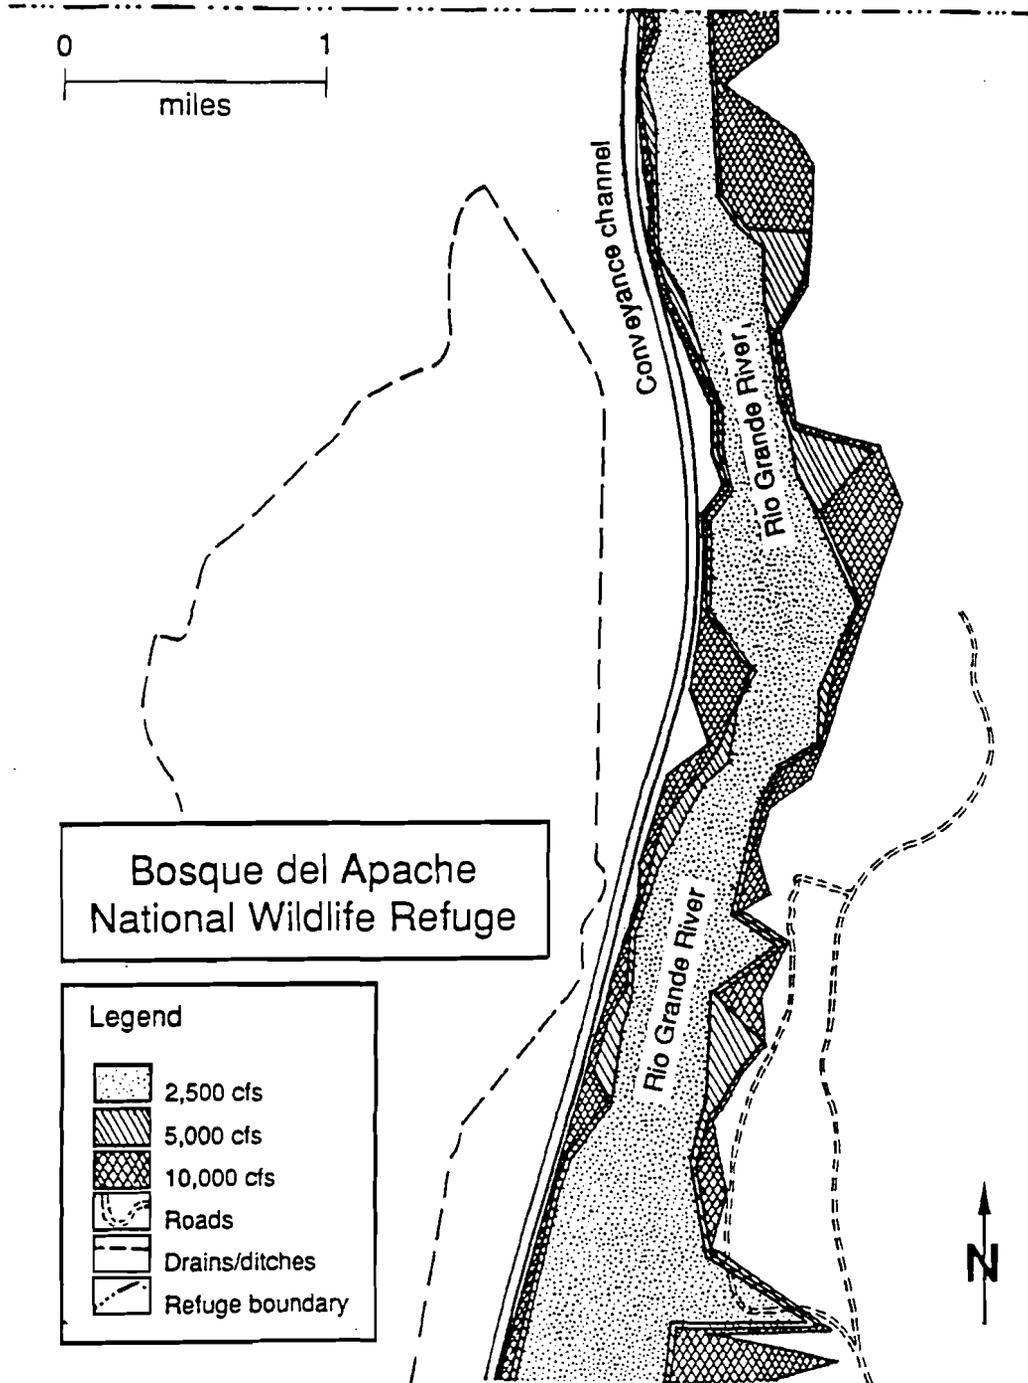
Fig. 35a. Map of the flooded area at three different discharges in a portion of the Bosque del Apache reach.
