**STREAMFLOW AND SEDIMENT DYNAMICS OF THE
MIDDLE RIO GRANDE VALLEY, NEW MEXICO,
IN THE CONTEXT OF COTTONWOOD RECRUITMENT**

**Technical Report
10 March 1993**

**U.S. Fish and Wildlife Service
National Ecology Research Center
4512 McMurry Avenue
Fort Collins, Colorado 80525-3400**

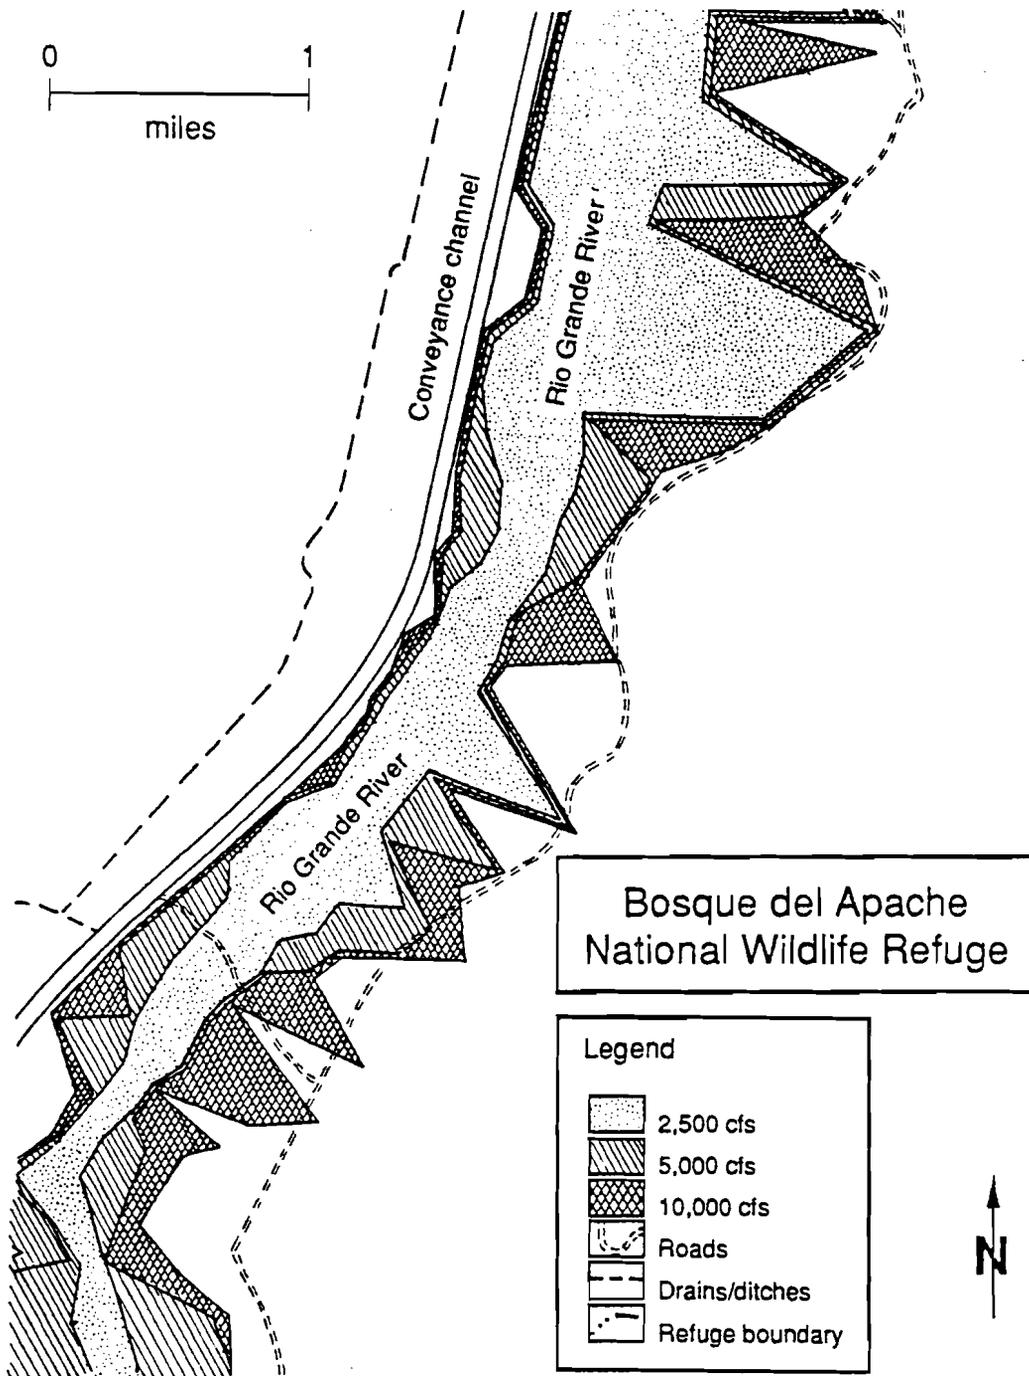
Fig. 35b. Map of the flooded area at three different discharges in a portion of the Bosque del Apache reach.

The final approach was to develop maps of the Bosque del Apache reach showing wetted area at different discharges (Figs. 34 and 35). The techniques and logic used to develop these maps are presented in Appendix A. If cottonwood establishment required only wet substrate, the maps would suffice. Unfortunately, the substrate may also need to be scoured. Velocities and shear stresses in the main channel and the side channels in the vicinity of Bosque del Apache NWR were investigated using HEC-6. The techniques used and details of the results are presented in Appendix B. Because of the dense stands of salt cedar and the existence of the jetty jacks, velocities associated with observed flows for the period 1965-1989 were almost certainly too low to cause scouring (Figs. 36 and 37). The velocity required to cause scouring is not known precisely, but certainly exceeds 1 foot per second.

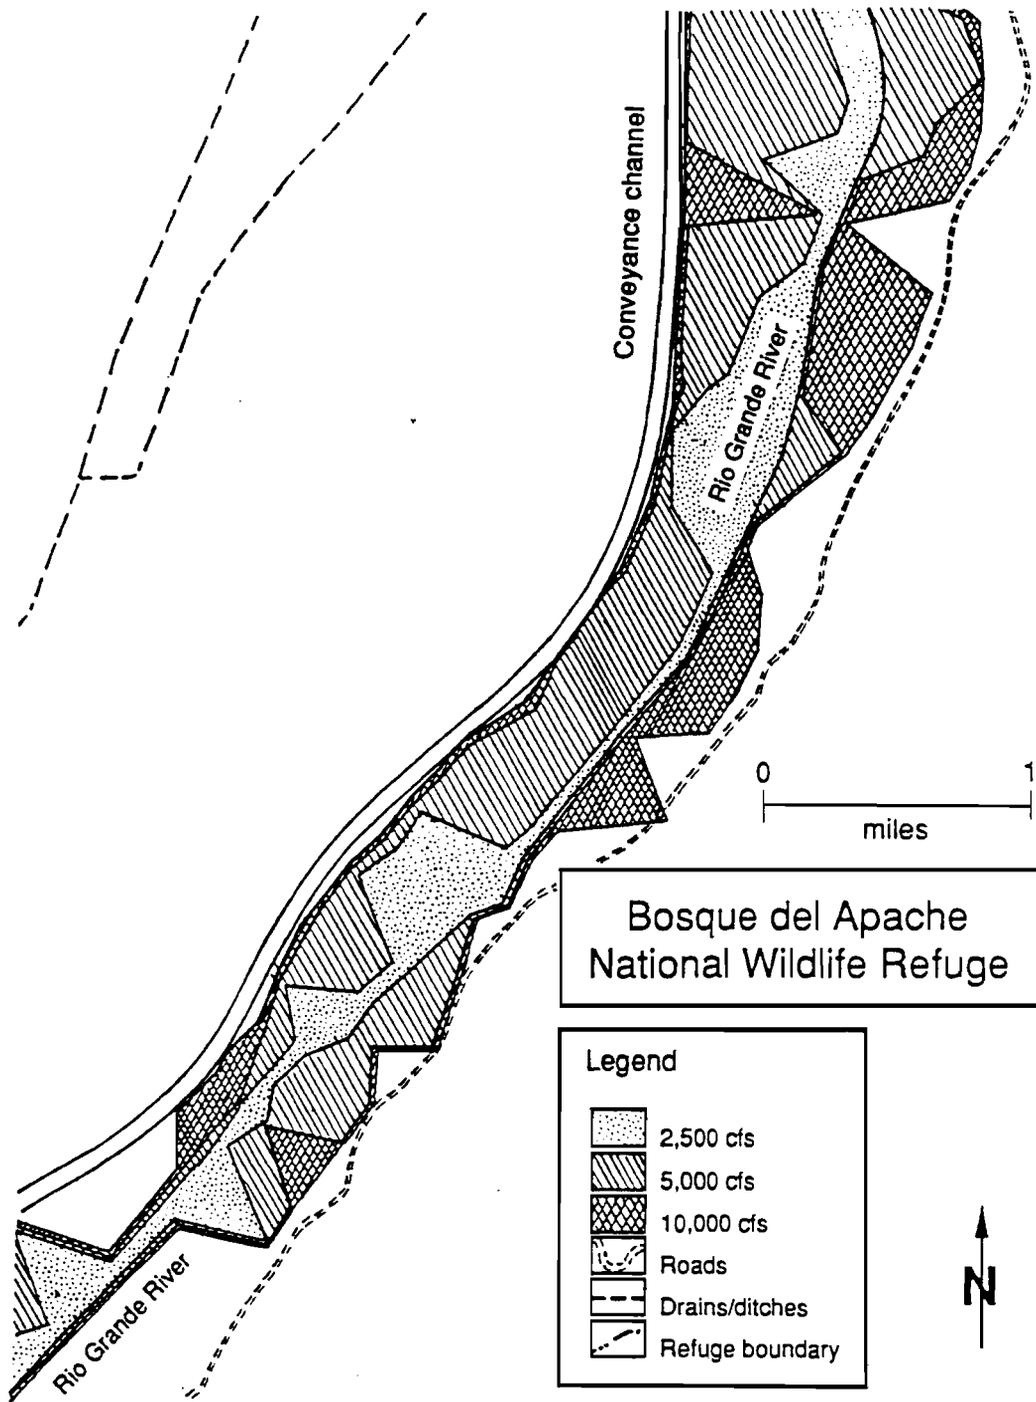
Fig. 35c. Map of the flooded area at three different discharges in a portion of the Bosque del Apache reach.

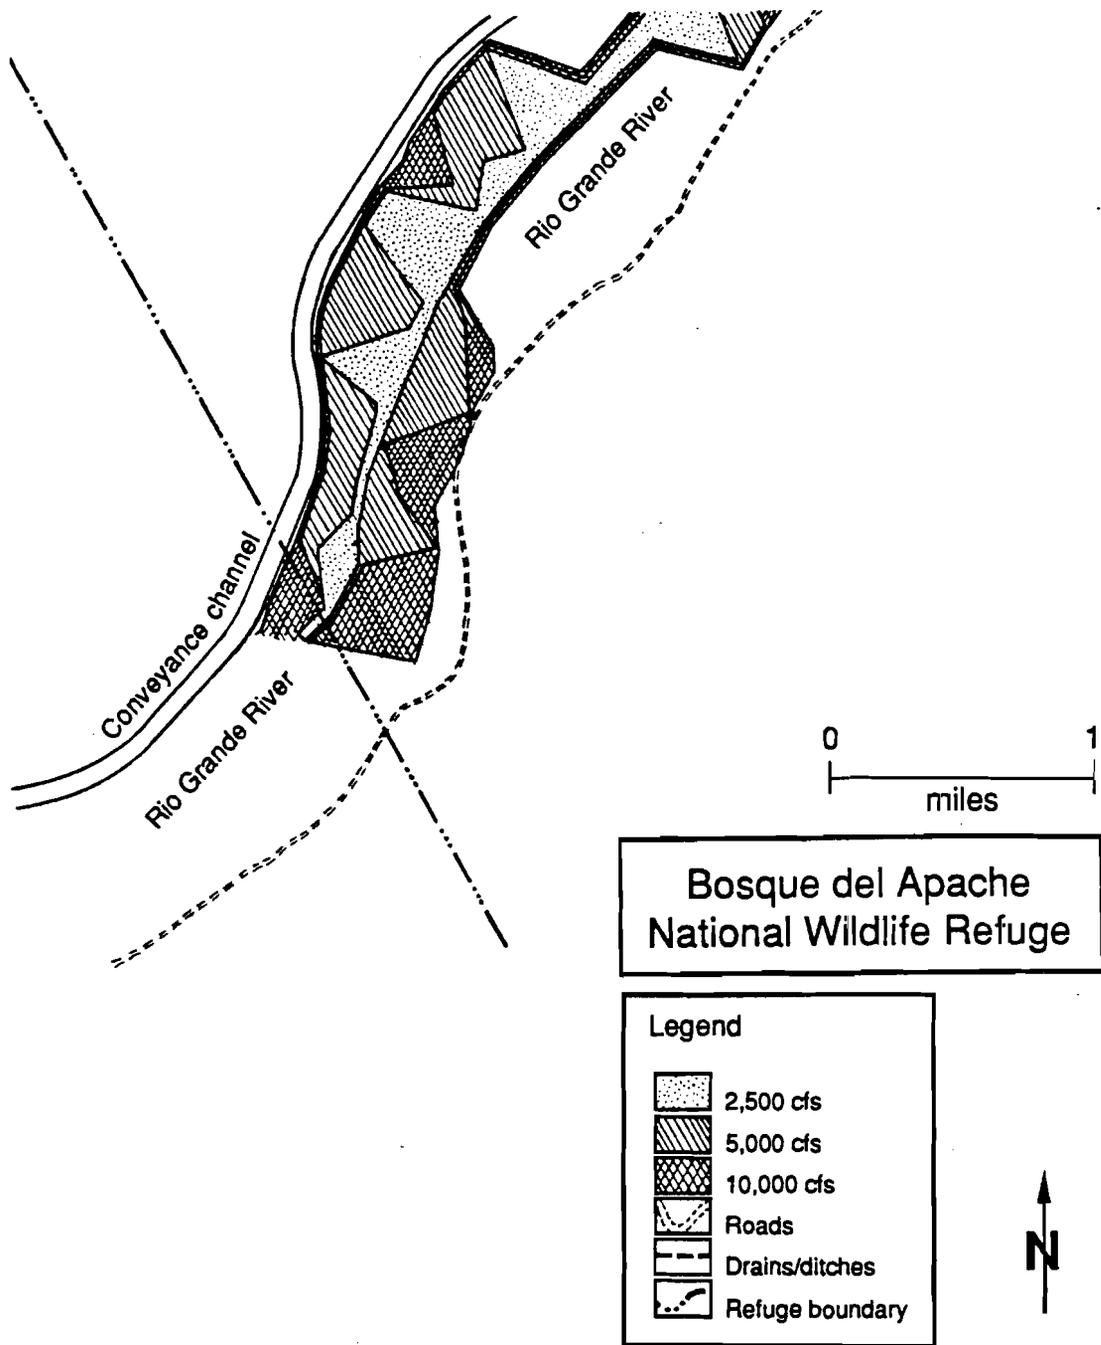
Fig. 35d. Map of the flooded area at three different discharges in a portion of the Bosque del Apache reach.

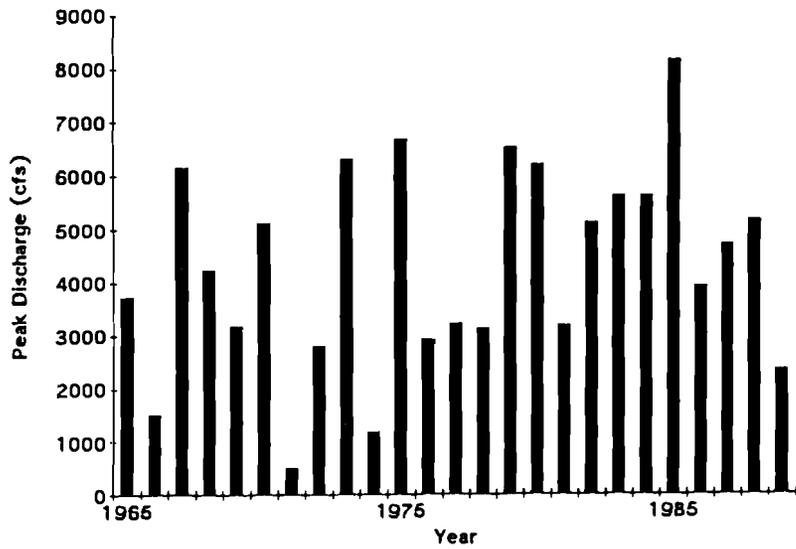
Fig. 36. Instantaneous peak flows at San Marcial, New Mexico, water years 1965-1989.

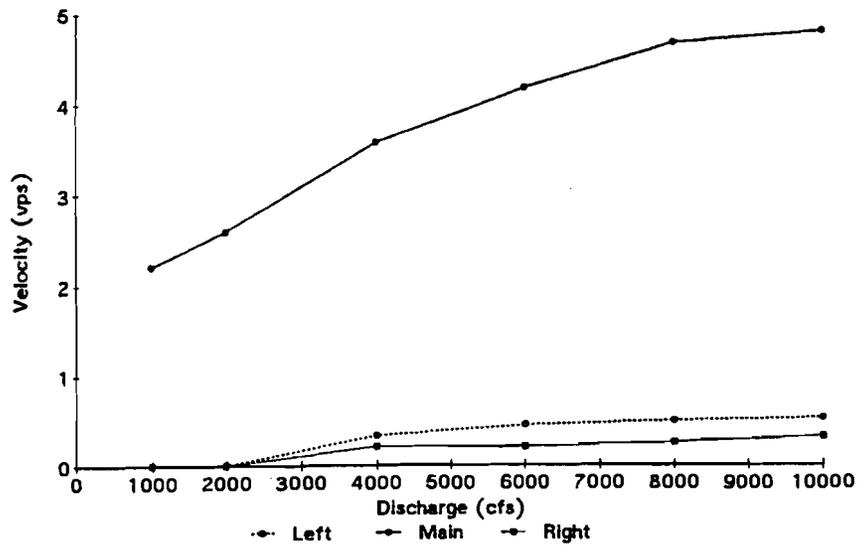
Fig. 37. Velocity versus discharge function for a section of the Bosque del Apache reach.
